Test Report

A 9072-4 / 2009

Contract : Testing of the water-tightness of a cable lead-through

System HSI 150-K2 packing and installed system cover HSI 150-S3 Segmento

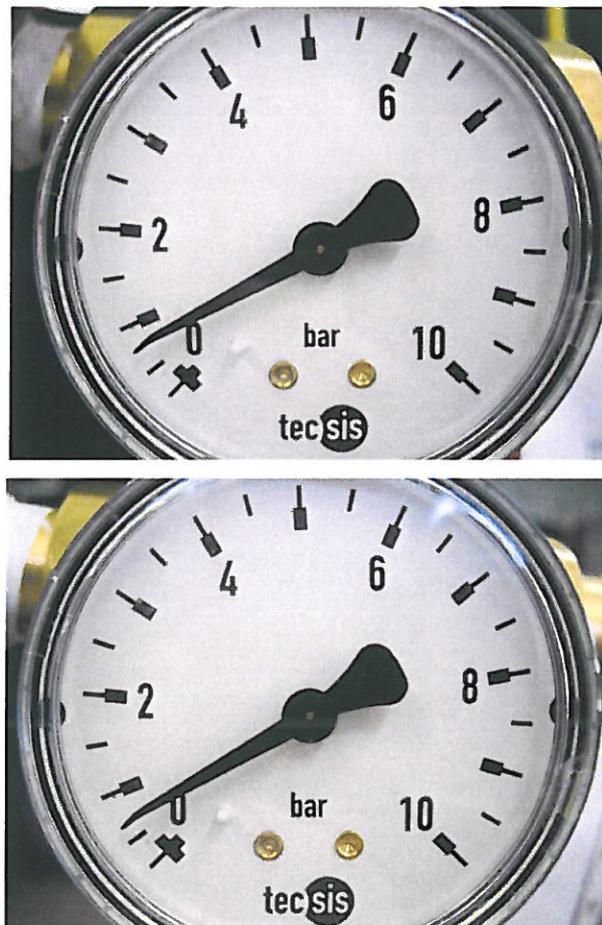
Subsequent the manometer display at the beginning and at the end of the tightness test is shown in Figure 5.

For example causal for the minor pressure decrease may be the hygroscopic properties of the concrete as well as a decrease of the tension force of the tension rods for the pressure bell fixing. A water discharge in the area of the sealing could not be detected.

Figure 5: Tightness test with water filled pressure bell (above: manometer display at the beginning of the test at 01/25/2010 09:30; below: manometer display at the end of the test at 01/26/2010 10:00)
