Project / Plant: Water tightness test of the stainless steel flange Hauff HRD150-F/100 for retrofit dowelling on a concrete test block with exterior waterproofing PCI Pecimor 2K (waterproofing class W2.1E according to DIN 18533-1)

Product description: Stainless steel flange Hauff HRD150-F/100 for retrofit dowelling

Order: Water tightness test $\geq 1,0$ bar for 28 days

Remark: Translation of Test Report A1742032-01,
15 June 2018

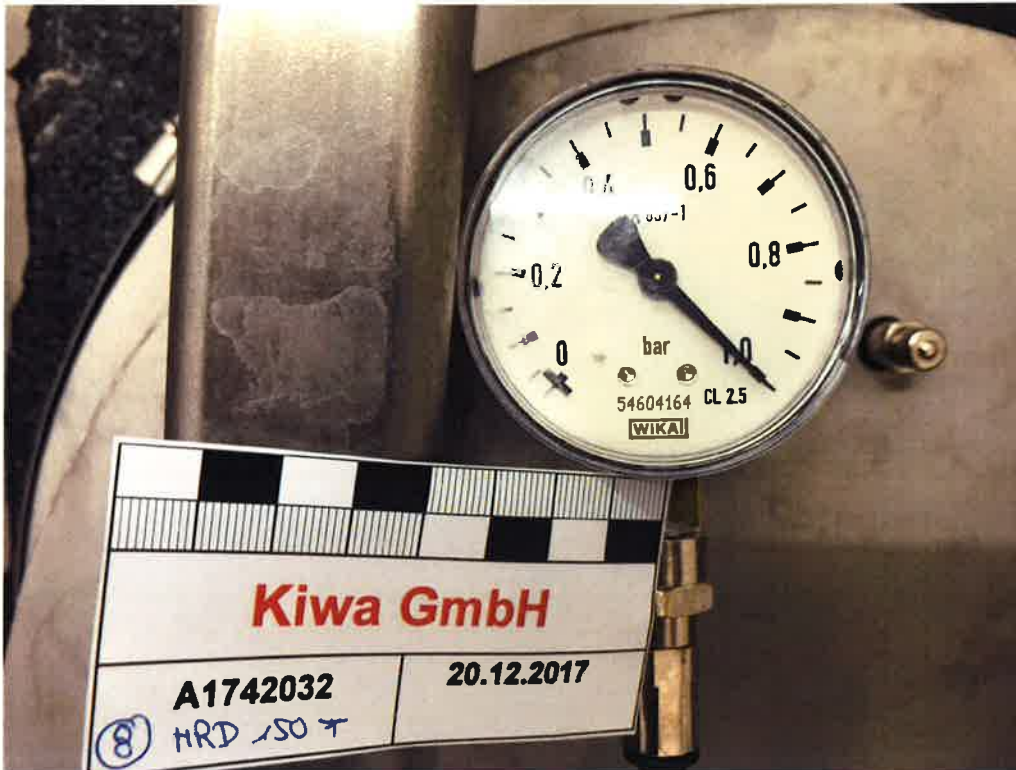
During the water tightness test no pressure drop as a result of leakages was detected (see Table 1). The test results can be seen at Figure A1 and Figure A2 attached in the annex.

Figure A1. Water tightness test with $\geq 1,0$ bar water filled test cylinder (manometer at the beginning of testing on 20.12.2017).

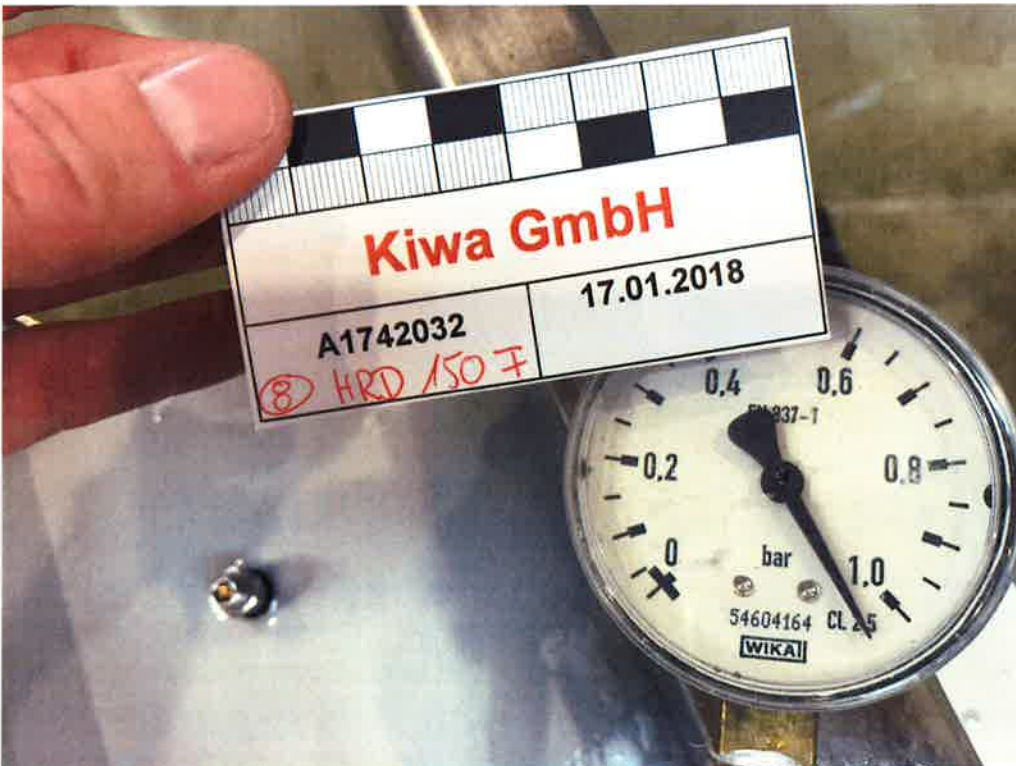
During the water tightness test of the stainless steel flange Hauff HRD150-F/100 which was installed in a concrete test block with exterior waterproofing PMBC PCI Pecimor 2K according to DIN EN 15814 no pressure drop as a result of leakages was detected during the testing period of 28 days with a permanent attached water pressure of ≥ 1,0 bar.

Figure A2. Water tightness test with $\geq 1,0$ bar water filled test cylinder (manometer after 28 days on 17.01.2018).
