## Test Report

Contract : Testing of the water-tightness of a sealing system

Universal casing UFR 200 with dummy plug  
HBD 200

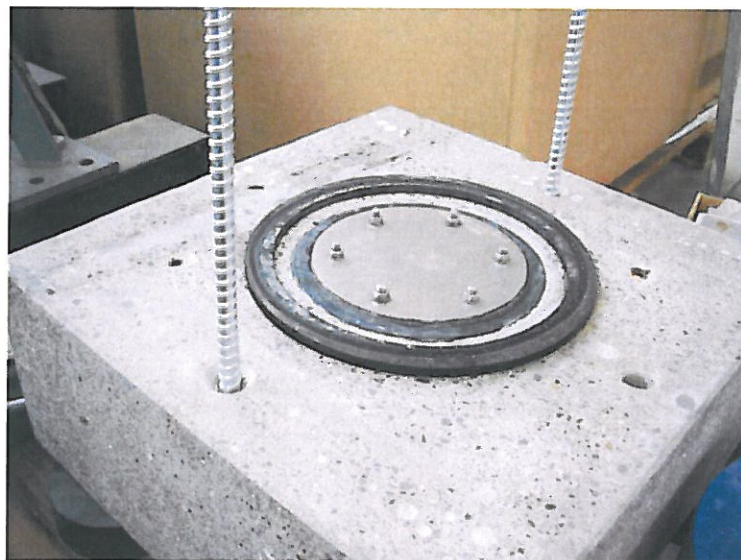
Figure 1: UFR 200 with installed HBD 200

The test setup consists of a concrete test member with a encased universal plastic casing UFR 200 with smoothing flange and with two profile web sealings and a dummy plug (in that case: foundation slab lead-through HBD 200).

A casing UFR 200 was encased in a concrete test member (ca. 40 x 40 x 30 cm). Afterwards the casing was assembled with a foundation slab lead-through HBD 200 in the function as a dummy plug. The grouting of the seal annulus (HBD) occurred in the middle of the concrete test member.

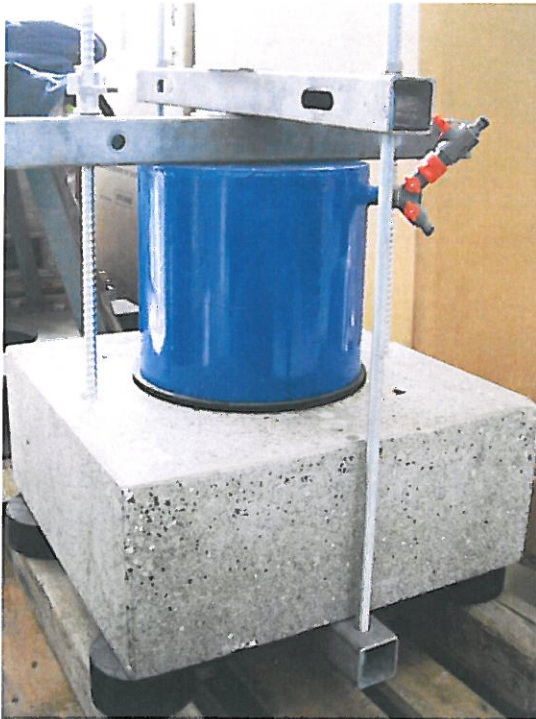
Figure 2: Test setup

Furthermore a compression bell with manometer and rubber ring seal was provided by the Manufacturer. The compression bell is designated to be put on the test member and pressed against the concrete by four tension rods (see Figure 2).

The test member which was delivered by the Manufacturer was a pre-assembled concrete test member with a test setup in accordance with section 2.1 and with a pre-assembled manometer (see Figure 2 to Figure 4). A calibration of the manometer was not carried out by Kiwa Bautest GmbH.

After consultation with the Manufacturer a tightness test with a water filled pressure bell over a period of 7 days with a nominal pressure of 2,5 bar was carried out. The filling of the pressure bell with water was carried out until the water-level reached the inlet and the air bleed valve respectively.
