Test Report

Order No.:
A 9071-1 / 2011

Contract : Test of the oil sealing over 90 days with the sealed inserts and concrete built-in parts:
- HEA-IS-M12/100
- HSI 150-DG
- HSI 150K/100 with HSI 150-D
- HSI 150 D3/58 with VS58/60, hot and cold shrink-on sleeve in HSI 150-K 100
- HSI 150 K2-100 with HRD150/160-G-3/20 (NBR)
- HSI 150 K2-100 with HSI 150-D
- Sikaflex Tank N sealing compound

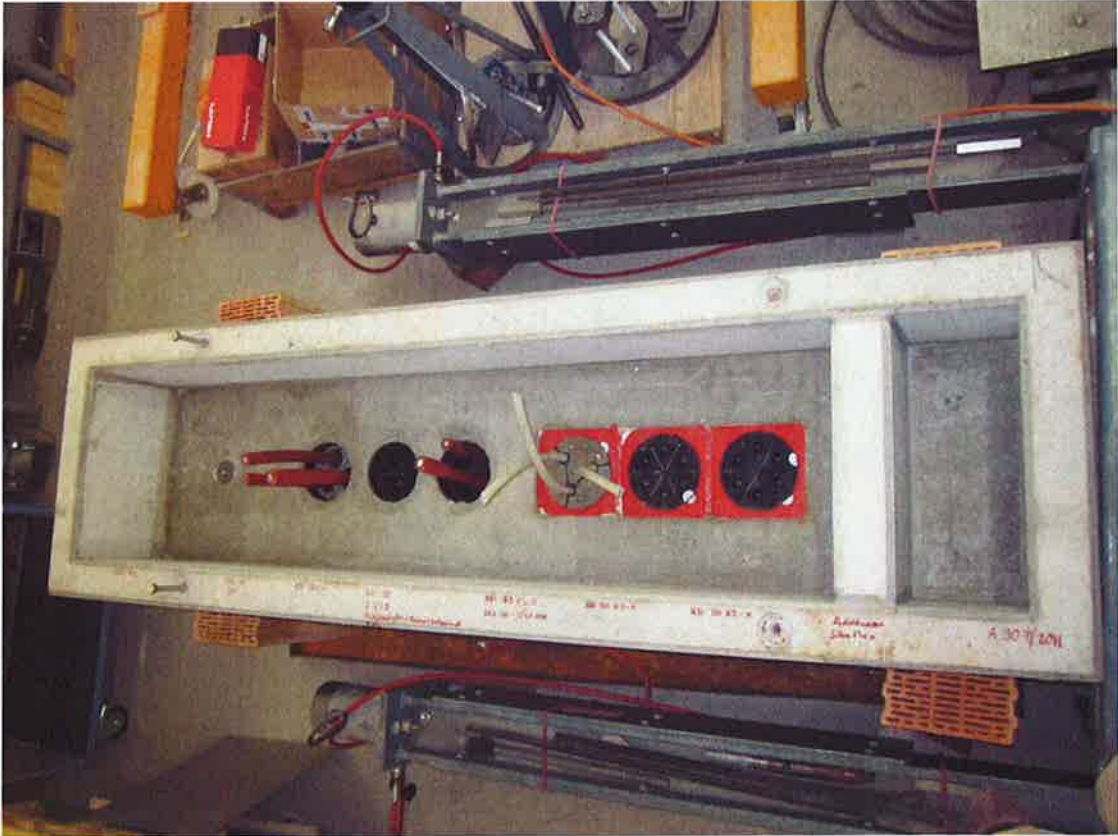
Illustration 1: Experimental setup, concrete trough with built-in sealed inserts and transverse bulkhead

A concrete trough with a total of seven built-in sealing inserts and concrete built-in parts and a transverse bulkhead sealed with a sealing compound was delivered by the Principal to our laboratory in

Illustration 1 to Illustration 8). Below are indicated the manufacturer's designations of the individual built-in sealing inserts:

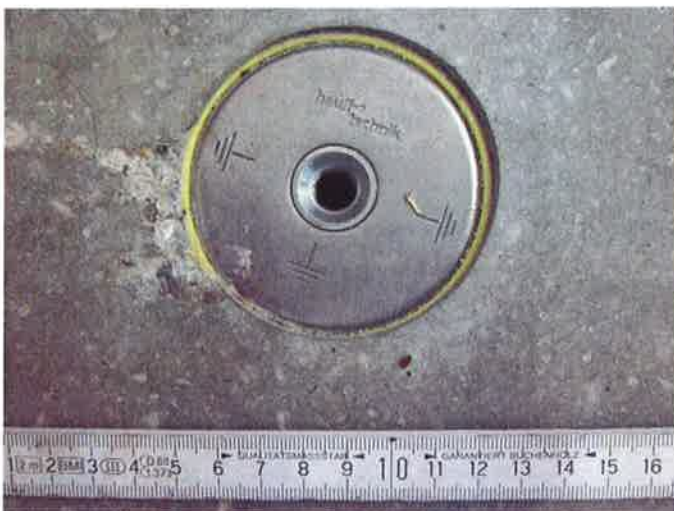
Illustration 2: Grounding penetration passage HEA-IS-M12/100, concrete trough inner side

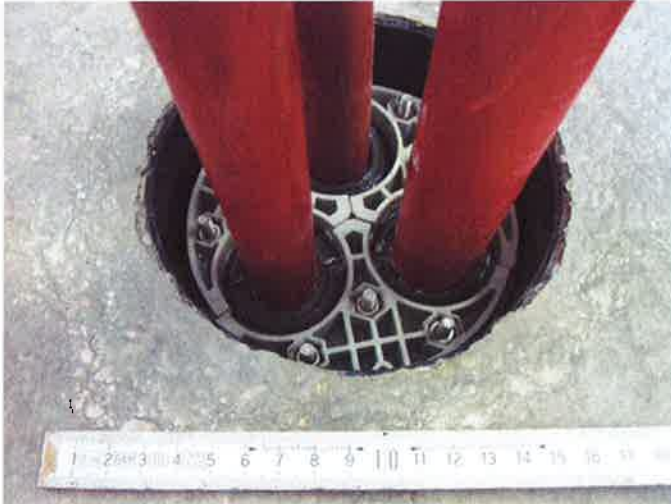
Illustration 3: HSI 150-DG, concrete trough inner side

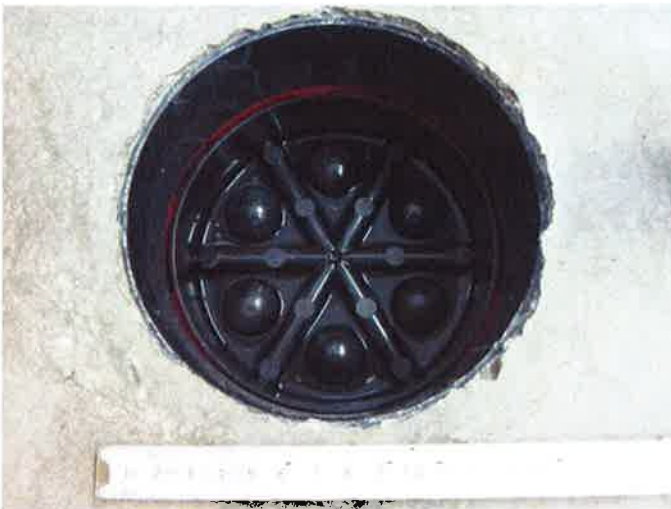
Illustration 4: HSI 150K/100 with HSI 150-D, concrete trough inner side

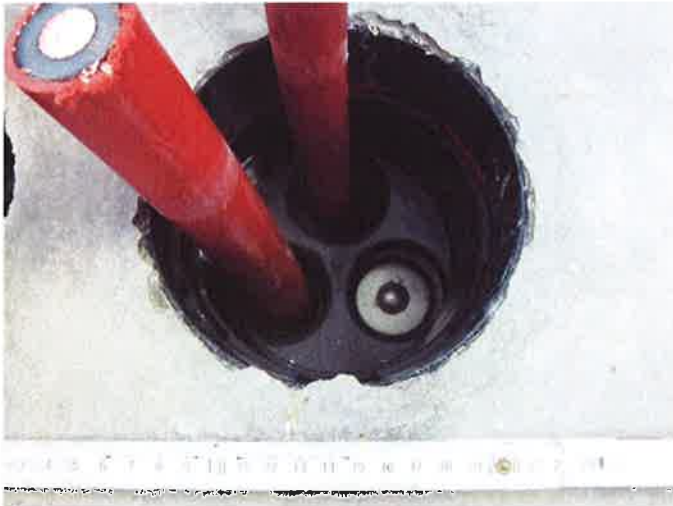
Illustration 5: HSI 150 D3/58 with seal plugs VS58/60, hot and cold shrink-on sleeve 150-K HSI 100, concrete trough inner side

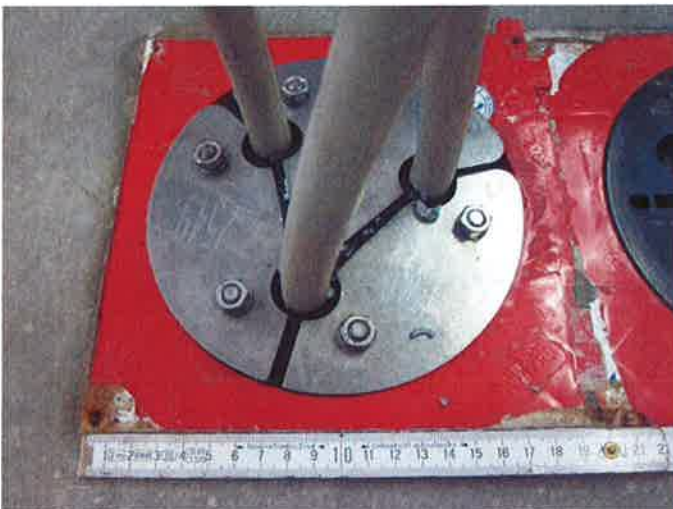
Illustration 6: HSI 150 K2-100 with HRD150/160-G-3/20 (NBR), concrete trough inner side

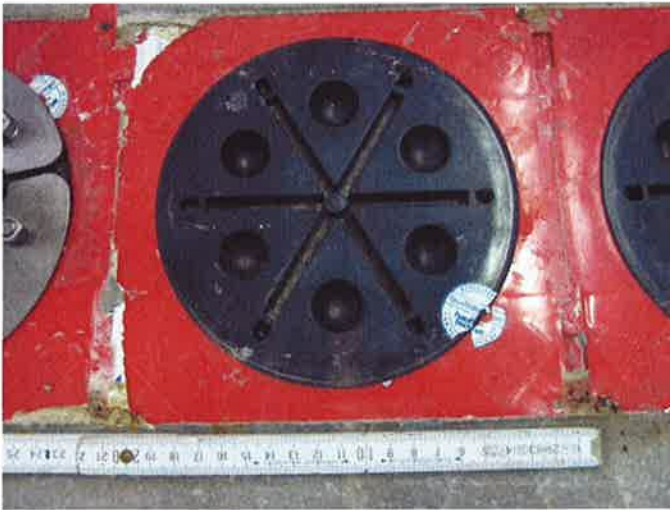
Illustration 7: HSI 150 K2-100 with close-off lid HSI 150-D (Experiment 1), concrete trough inner side

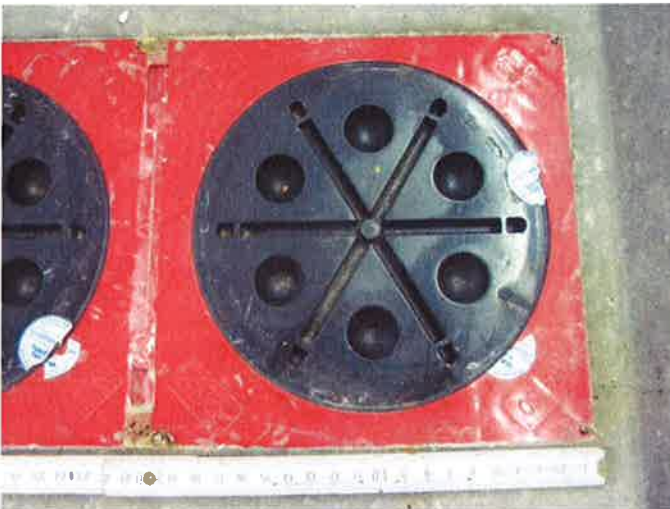
Illustration 8: HSI 150 K2-100 with close-off lid HSI 150-D (Experiment 2), concrete trough inner side

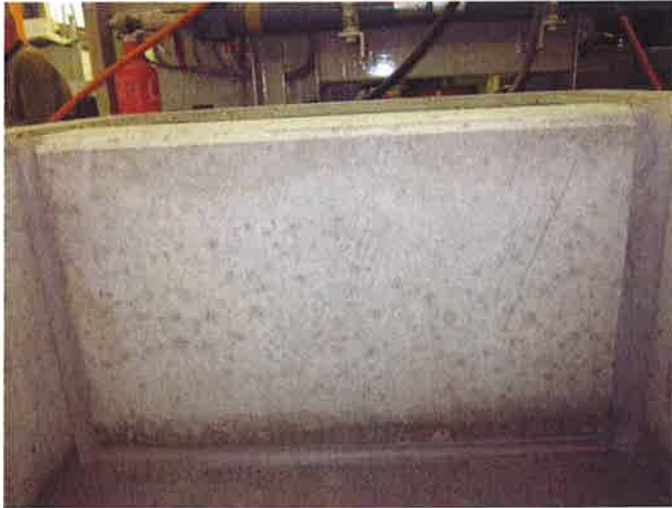
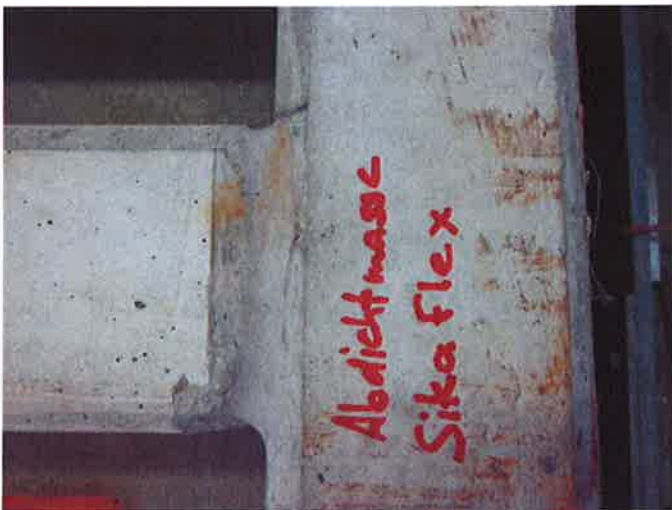
Illustration 9: Transverse bulkhead sealed with sealant mass Sikaflex Tank N
(side view and top view)

The transverse bulkhead was sealed, according to the specifications of the manufacturer, with a sealant mass of the type Sikaflex Tank N at the impingement contact points (see Illustration 9).

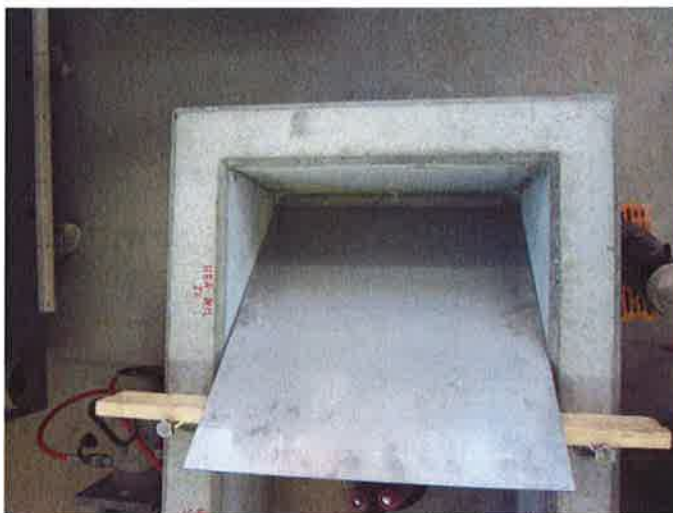
Illustration 10: Sheet steel with base recesses as a pouring help for the insertion of the oil

The pouring in of the oil was implemented using a plate inserted diagonally into the trough. The volume of the oil was selected so that, at every location of the concrete trough, the base was covered with at least 15 mm of oil.

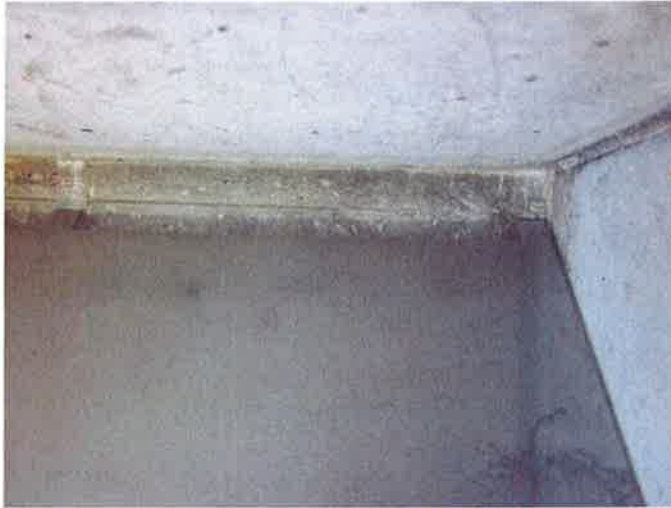
Illustration 11: Sheet steel base recess

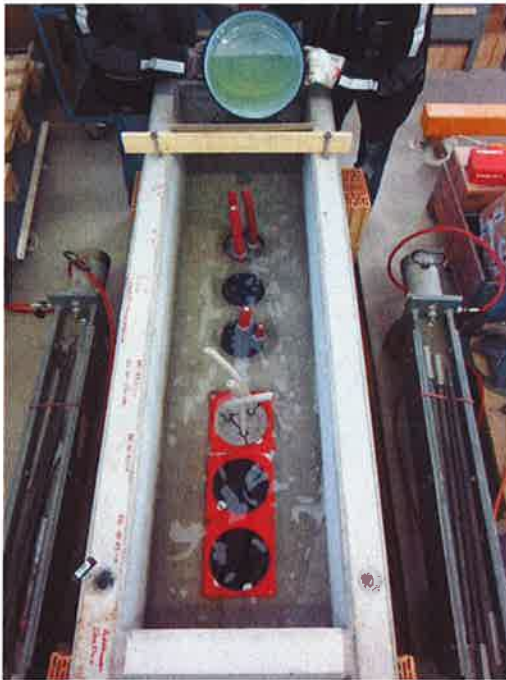
Illustration 12: Pouring the heated oil (90.0°C) into the concrete trough

The implementation of the sealing test was carried out over the entire test period at room temperature. Deviating from this, the oil was heated up to 90.0°C before pouring into the concrete trough, and then cooled down in the concrete trough to room temperature. The concrete temperature of the trough was 12.5°C at the time of the pouring in of the oil.

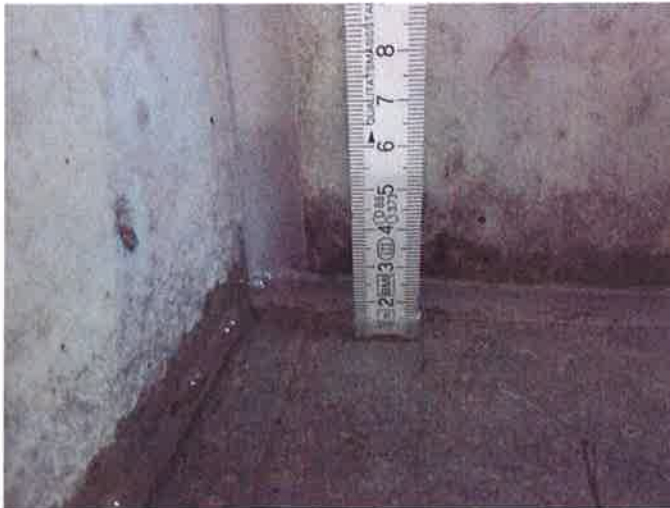
Illustration 13: Oil level in the trough immediately after the insertion of the oil in the area of the sealing joint (approx. 15 mm)

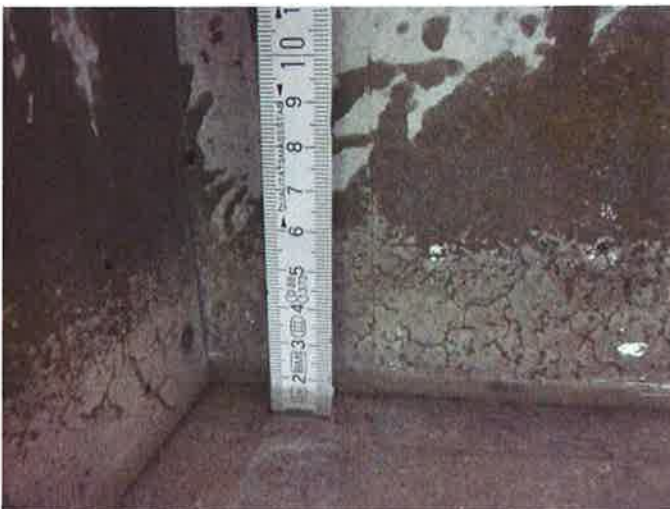
Illustration 14: Oil level in the trough immediately after the insertion of the oil in the area of the pouring location (approx. 16 mm)

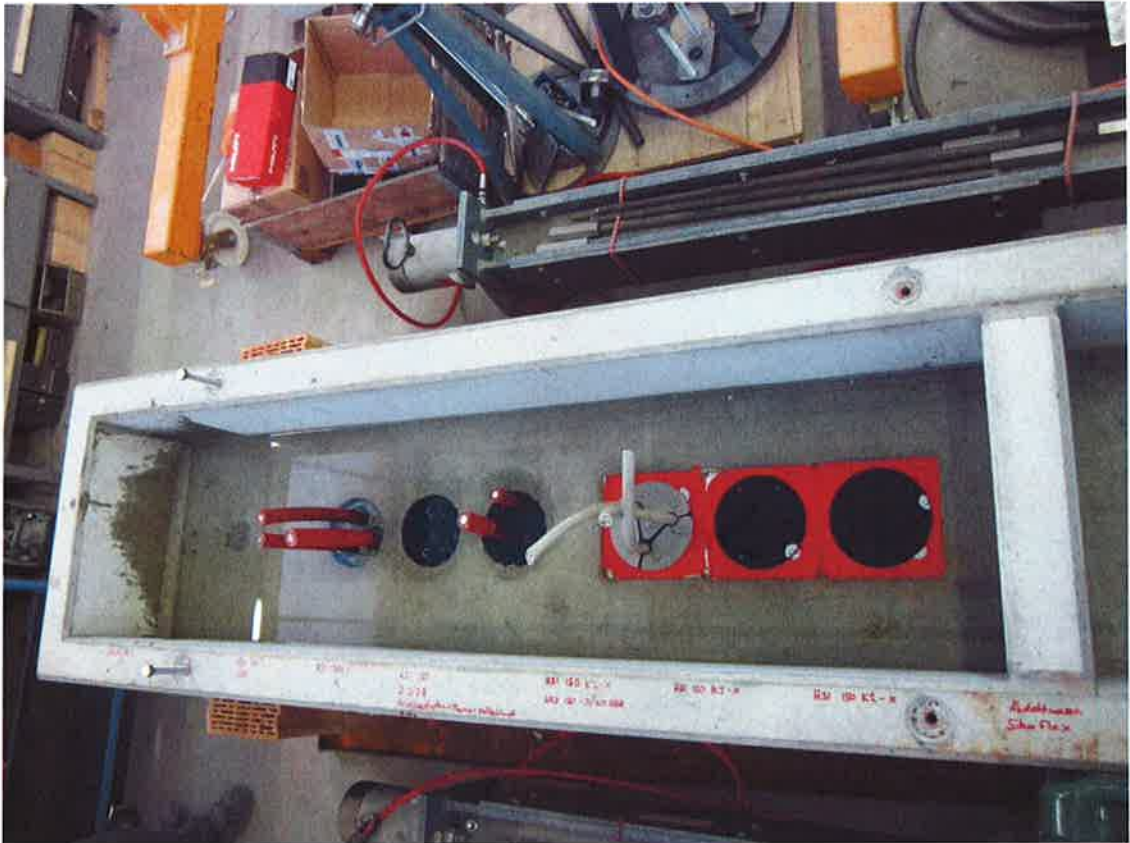
Illustration 15: Concrete trough ready and filled with insulating oil

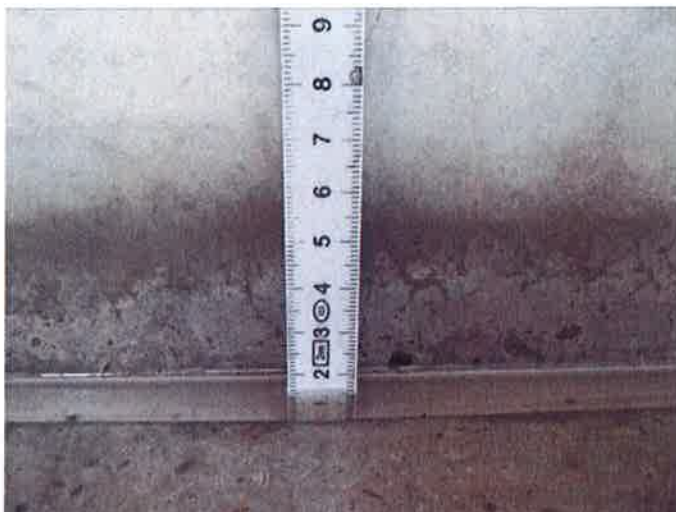
Illustration 16: Oil level in the trough at trial end after 92 days oil impingement contact in the area of the sealing joint (approx. 15 mm)

During entire test time period no leaks could be determined at the underside of the concrete trough or on the side facing the oil of the transverse bulkhead at the sealing joint.

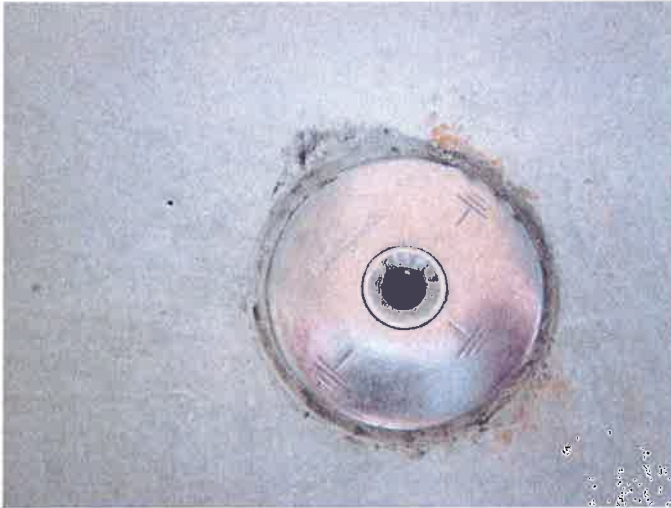
Illustration 17: Grounding penetration passage HEA-IS-M12/100, trough under-side after 92 days

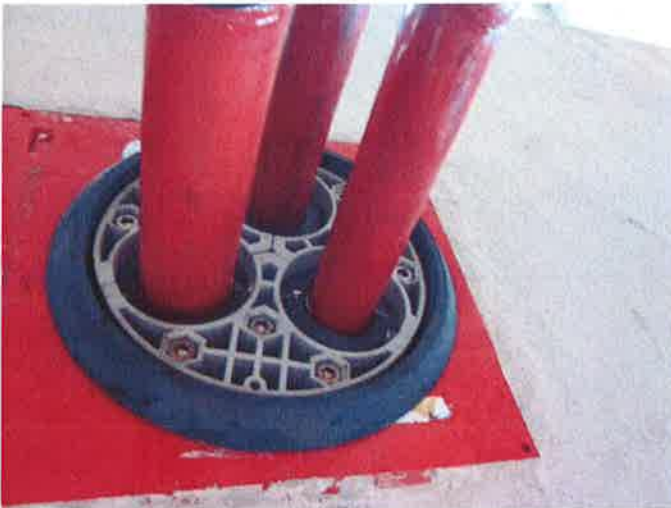
Illustration 18: HSI 150-DG, trough under-side after 92 days

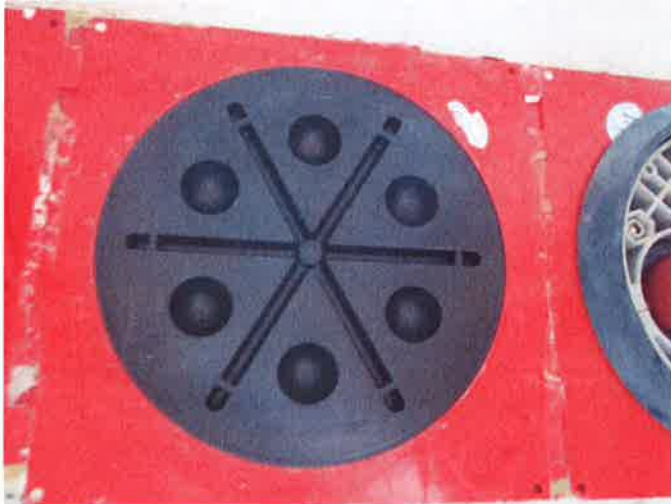
Illustration 19: HSI 150K/100 with HSI 150-D, trough under-side after 92 days

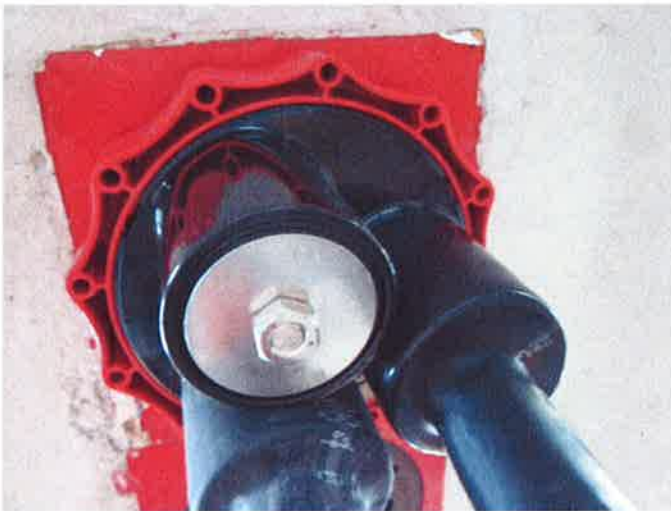
Illustration 20: HSI 150 D3/58 with seal plugs VS58/60, hot and cold shrink-on sleeve in HSI 150-K 100, trough under-side after 92 days

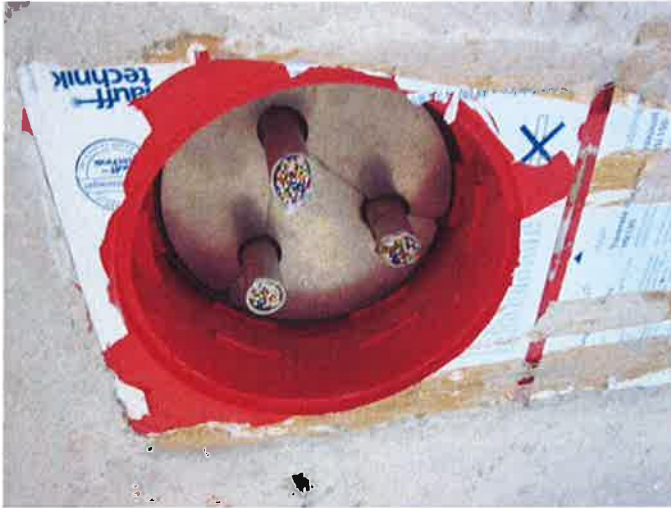
Illustration 21: HSI 150 K2-100 with HRD150/160-G-3/20 (NBR), trough under-side after 92 days

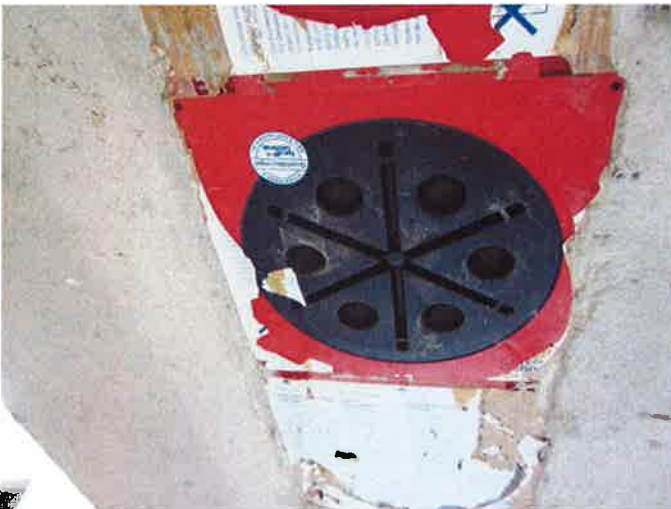
Illustration 22: HSI 150 K2-100 with close-off lid HSI 150-D (1st experiment), trough under-side after 92 days

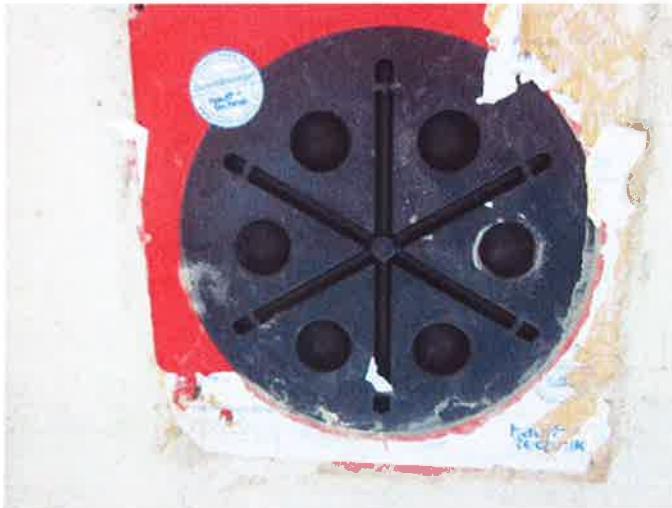
Illustration 23: HSI 150 K2-100 with close-off HSI 150-D (2nd experiment),
trough under-side after 92 days

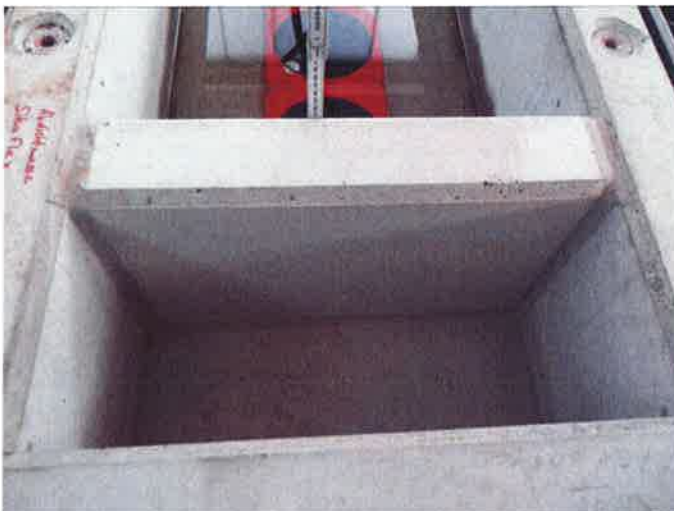
Illustration 24: Transverse bulkhead, side facing the oil

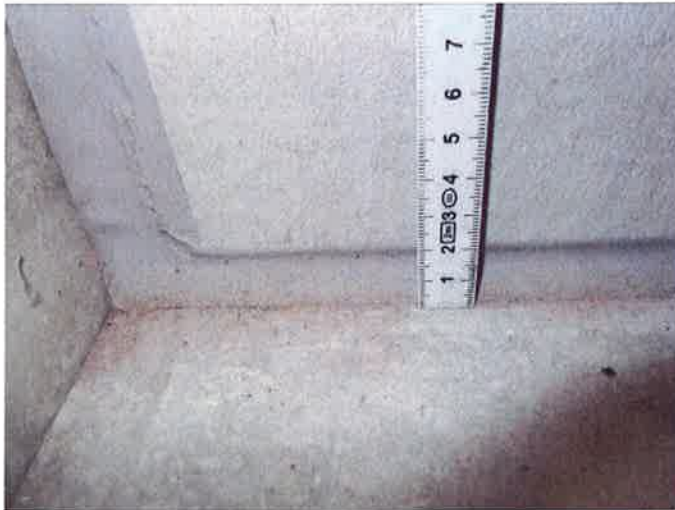
Illustration 25: Sealing joint Sikaflex Tank N on the side facing the oil after 92 days

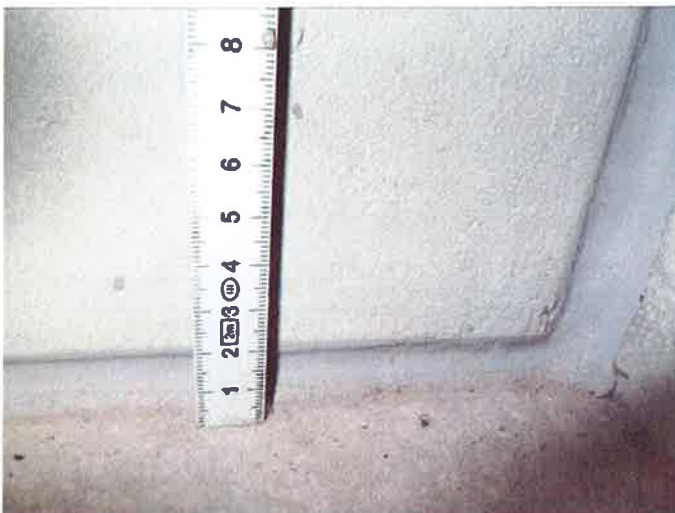
Illustration 26: Sealing joint Sikaflex Tank N on the side facing the oil after 92 days
