## Test Report

Hauff-Technik GmbH & Co. KG  
Giengener Straße 35  
89428 Syrgenstein

Contract : Testing of the gas tightness of the ring sealing  
HSD 100-SSG-18-65 for building entries with  
compressed air at a test temperature of 23 °C

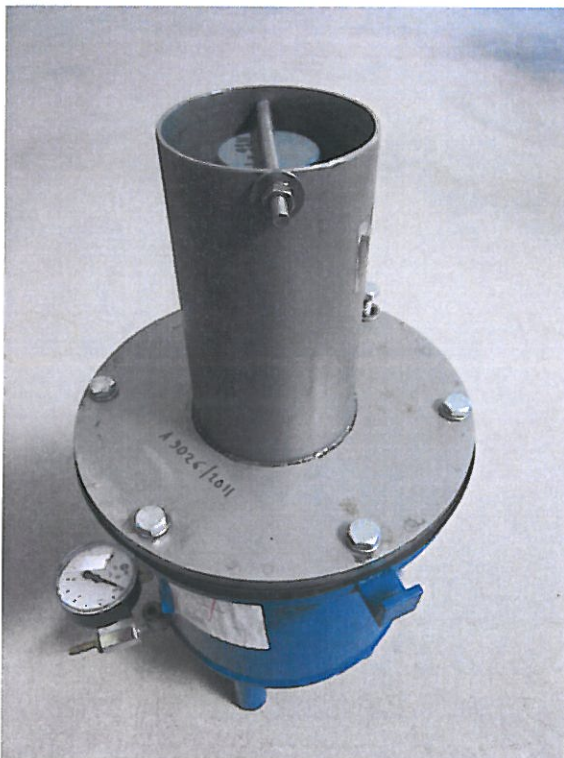
Figure 1: Test setup

The test member which was delivered by the Manufacturer was a pre-assembled test member with a test setup in accordance with section 2.1 and with a pre-assembled manometer (see Figure 1 and Figure 3). A calibration of the manometer by Kiwa MPA Bautest GmbH was not carried out.

The ring sealing system HSD 100-SSG-18-65 was installed in a testing cylinder as shown in Figure 1 and Figure 3. The used sealing insert was assembled with one dummy plug Ø 45 mm.

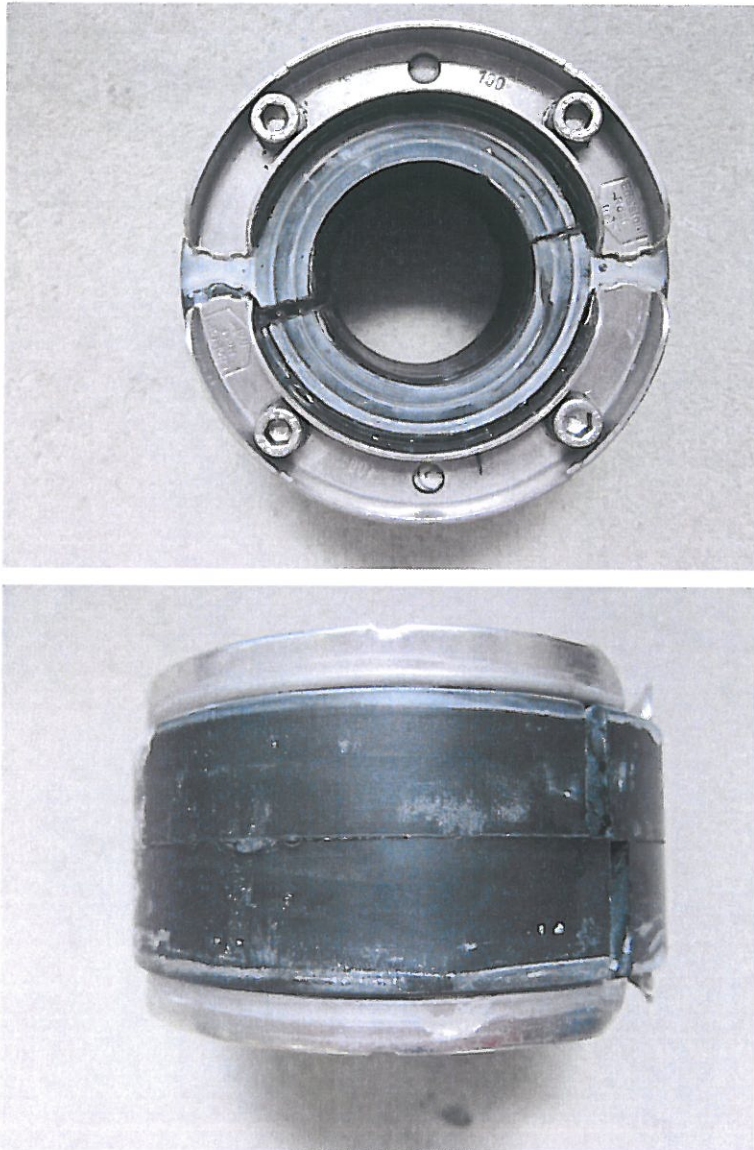
Figure 2: Ring sealing HSD 100-SSG-18-65

The ring sealing system HSD 100-SSG-18-65 is a divided seal insert with an insert for one cable for use as a cable lead-through for buildings with an existing casing or core hole of Ø 102 mm. HSD 100-SSG-18-65 is a sealing insert of rubber EPDM with a sealing width of 40 mm.

After consultation with the Manufacturer a tightness test with compressed air over a period of 24 h with a nominal pressure of 5 bar and a test temperature of 23 °C was carried out with a test specimen as shown in Figure 2.

Subsequent a second tightness test with compressed air over a period of 24 h with a nominal pressure of 6 bar and a test temperature of 23 °C was carried out with a test specimen as shown in Figure 2.

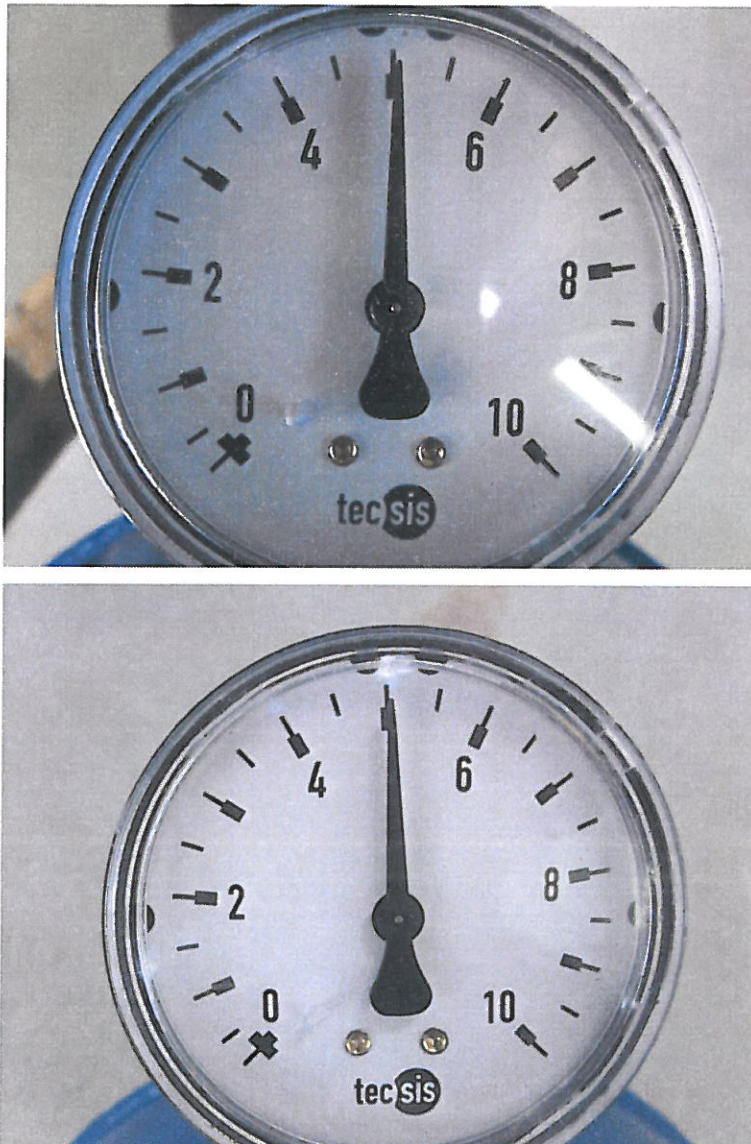
Figure 4: Tightness test with compressed air (5 bar) filled pressure bell at 23 °C (above: manometer display at the beginning of the test/ at 04/18/2011 07:45; below: manometer display at the end of the test/ at 04/19/2011 10:10)

Subsequent in Figure 4 to Figure 5 the manometer display at the beginning and at the end of the tightness tests are shown.

*During the tightness tests of the ring sealing system HSD 100-SSG-18-65 at a test temperature of 23 °C with compressed air filled pressure bell with nominal pressure of 5 bar and 6 bar respectively over the respective test period of 24 h no defect could be detected.*

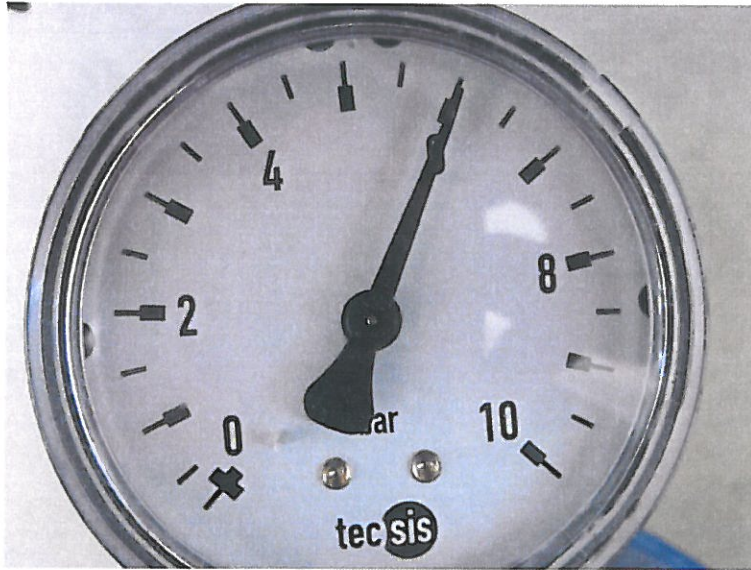
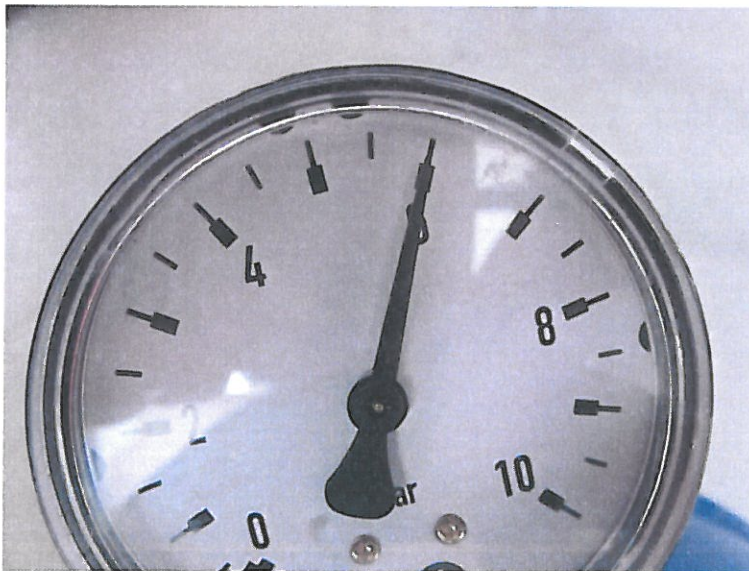
Figure 5: Tightness test with compressed air (6 bar) filled pressure bell at 23 °C (above: manometer display at the beginning of the test at 04/19/2011 11:30; below: manometer display at the end of the test at 04/20/2011 11:30)
