## Test Report

A 9056-1 (eng) / 2016

Product : Floor entry Hauff HMK110 without clamping strap  
Project : Testing of the water tightness of the floor entry Hauff HMK110 without clamping strap  
Sample delivery by : RAU-Betonfertigteile GmbH & Co. KG  
Hauff-Technik GmbH & Co. KG  
Testing period : August 9<sup>th</sup> - October 28<sup>th</sup> 2016  
Tested by : Kiwa GmbH, Bautest Augsburg  
Contact : B. Eng. David Röck  
Tel. +49 821 72024-14  
Remark : Translation of Test Report A 9056-1 / 2016  
Date in preparation

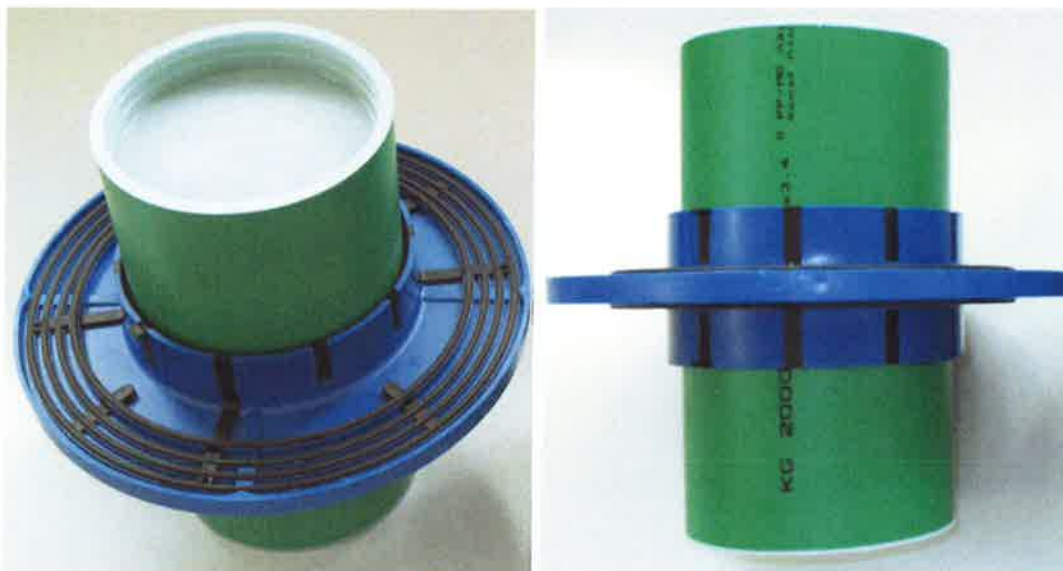
Figure 1. Used floor entry Hauff HMK110 without clamping strap.

For the test a floor entry Hauff HMK110 without clamping strap (see Figure 1) was delivered by Hauff-Technik GmbH & Co. KG to our laboratory in Augsburg. The production of the concrete specimen with the cast in floor entry was performed by RAU-Betonfertigteile GmbH & Co. KG. The test setup was built up by employees of Hauff-Technik GmbH & Co. KG at Kiwa GmbH in Augsburg (see Figure 2).

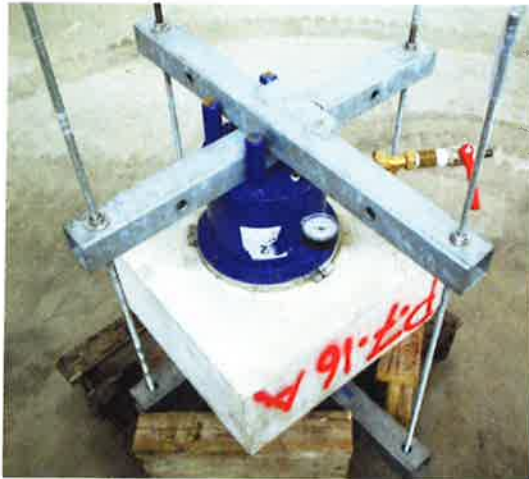
Figure 2. Example for a test setup.

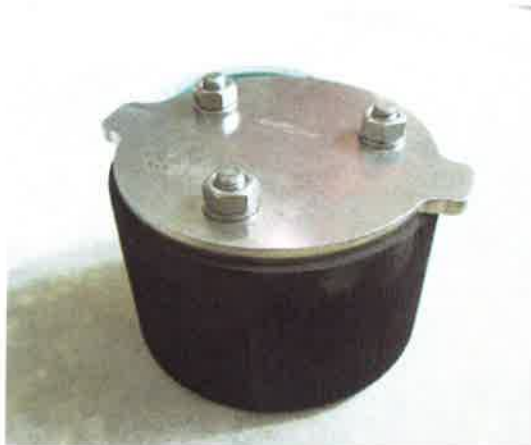
Figure 3. Example for a Hauff HRD104-0 blind plug.

The opening of the floor entry was sealed on the formwork smooth surface with a Hauff HRD104-0 blind plug (see Figure 3). Afterwards Hauff Technik GmbH & Co. KG attached a pressure bell with pressure reducer and manometer above the blind seal. The sealing of the pressure bell was performed with the help of a 40 mm thick EPDM sealing (see Figure 4) and clamping pressure.

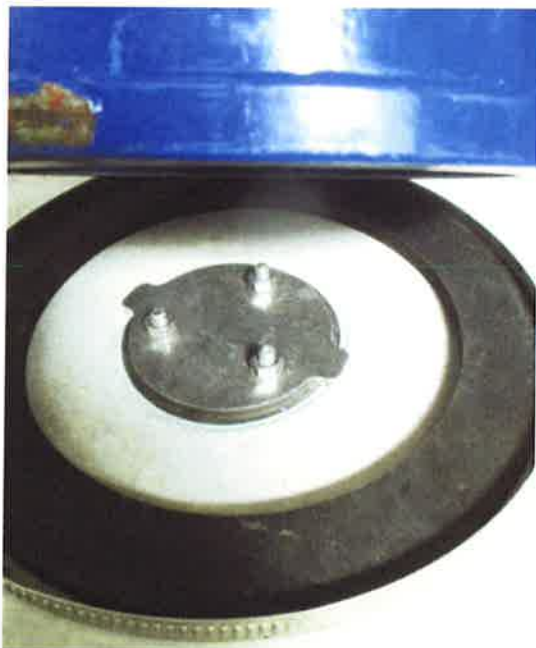
Figure 4. Example for a 40 mm thick EPDM sealing.

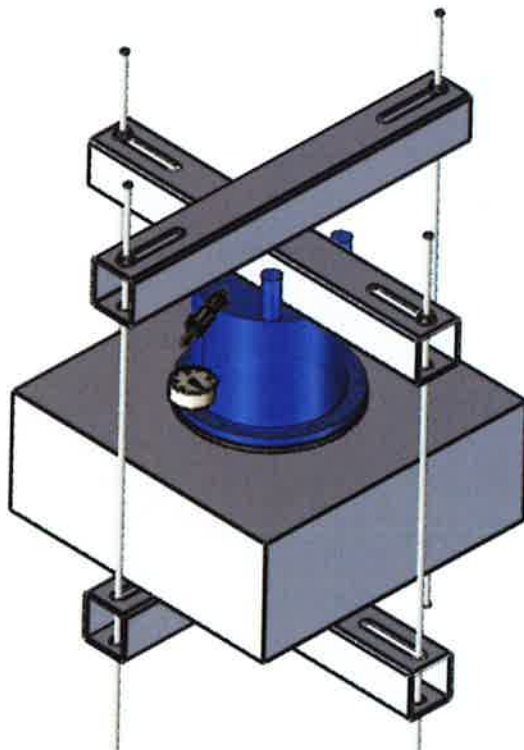
Figure 5. Detail of the test setup - manufacturer's drawing.

The test setup which was assembled by Hauff-Technik GmbH & Co. KG was built up in accordance to Section 2.1 with one manometer (see Figure 5 to Figure 6).

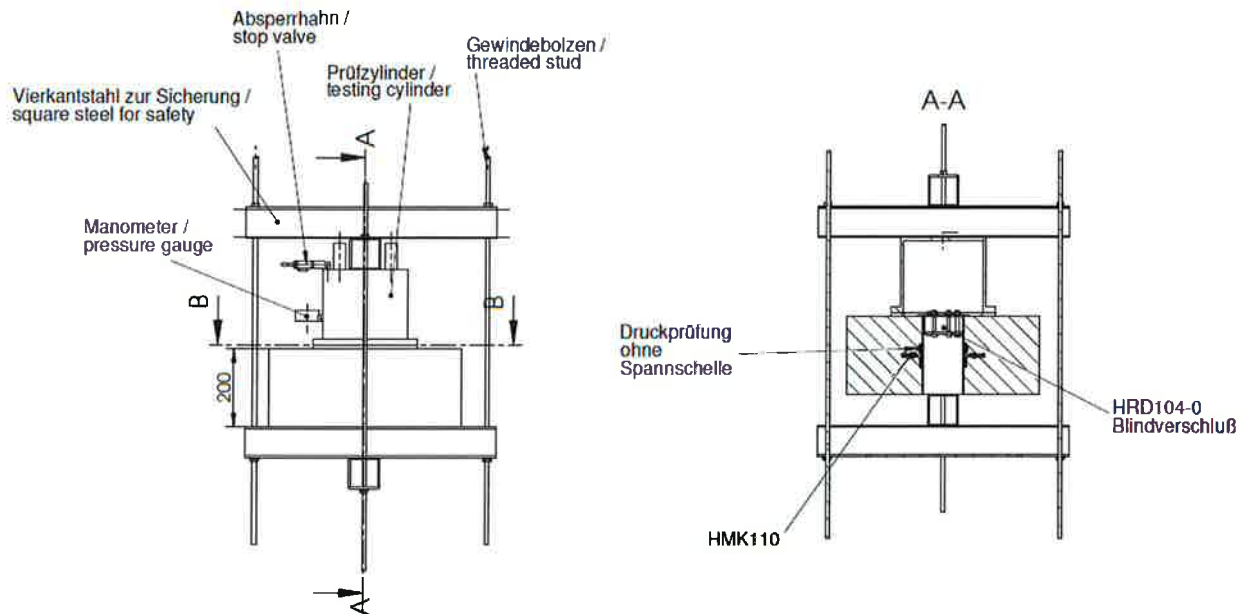
Figure 6. Detail and cross-section through the test setup - manufacturer`s drawing.

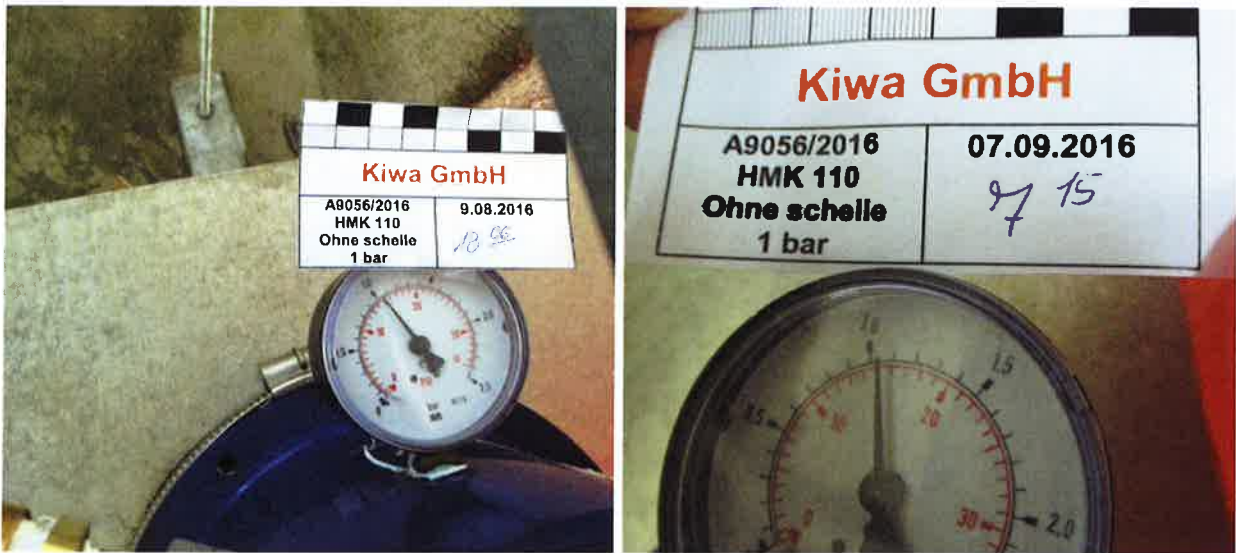
Figure A1. Water tightness test with the 1,0 bar water filled pressure bell (left: manometer at the beginning of testing on August 9<sup>th</sup>, 2016 at 6:06 pm; right: manometer after 28 days on September 7<sup>th</sup>, 2016 at 7:15 am).

During the water tightness test no leakages were detected (see Table 2). The water pressure depending on the testing period can be seen at Figure A1 to Figure A4 attached in the annexes.

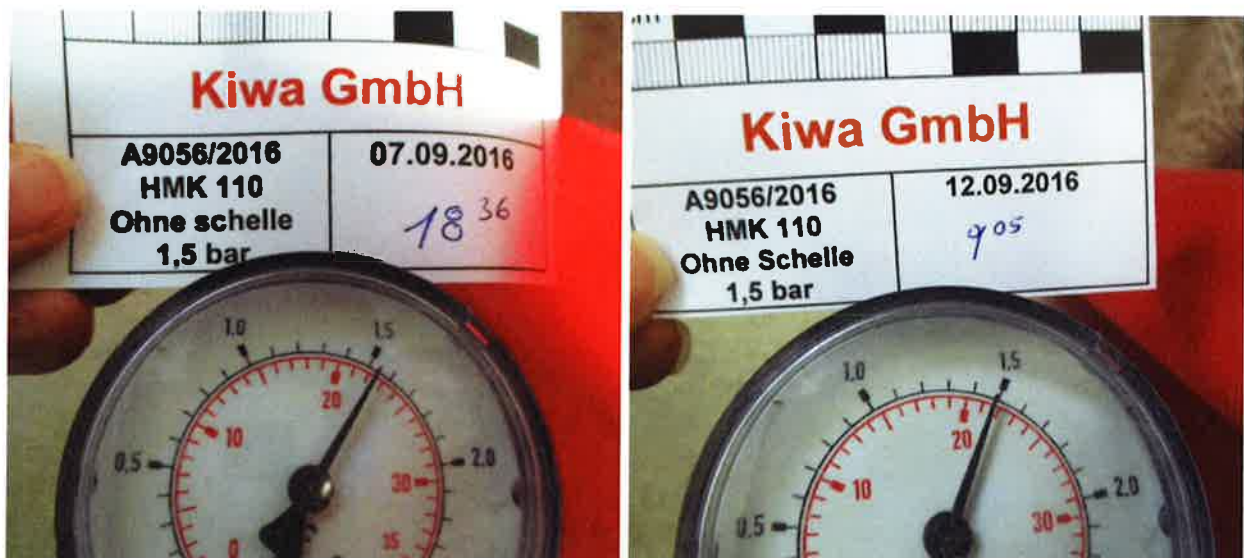
Figure A2. Water tightness test with the 1,5 bar water filled pressure bell (left: manometer on September 7<sup>th</sup>, 2016 at 6:36 pm; right: manometer after 4 days on September 12<sup>th</sup>, 2016 at 9:05 am).

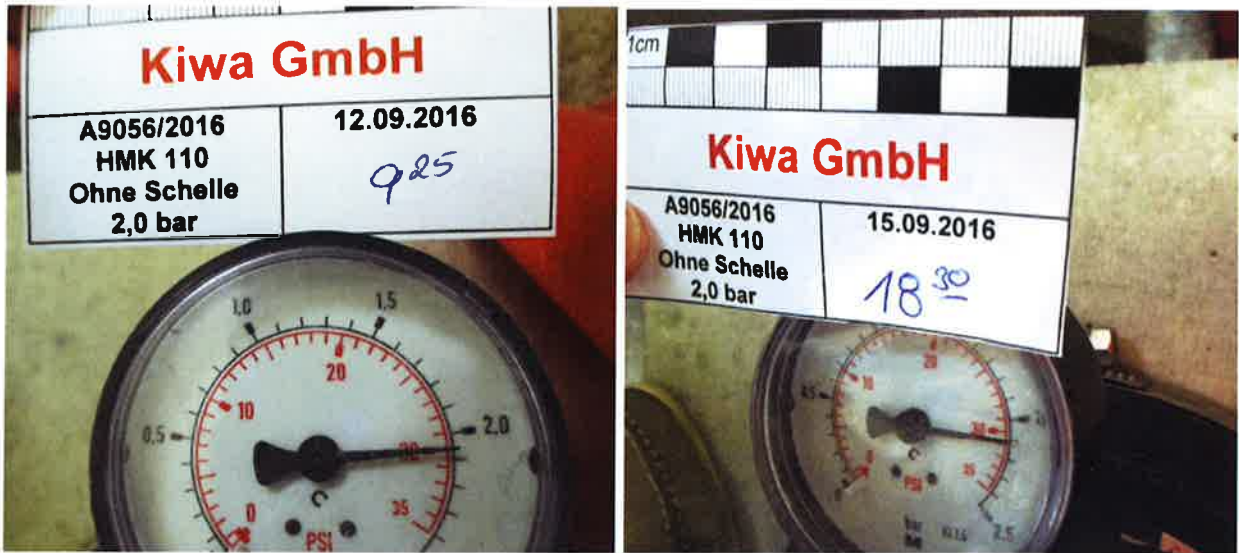
Figure A3. Water tightness test with the 2,0 bar water filled pressure bell (left: manometer on September 12<sup>th</sup>, 2016 at 9:25 am; right: manometer after 3 days on September 15<sup>th</sup>, 2016 at 6:30 pm).

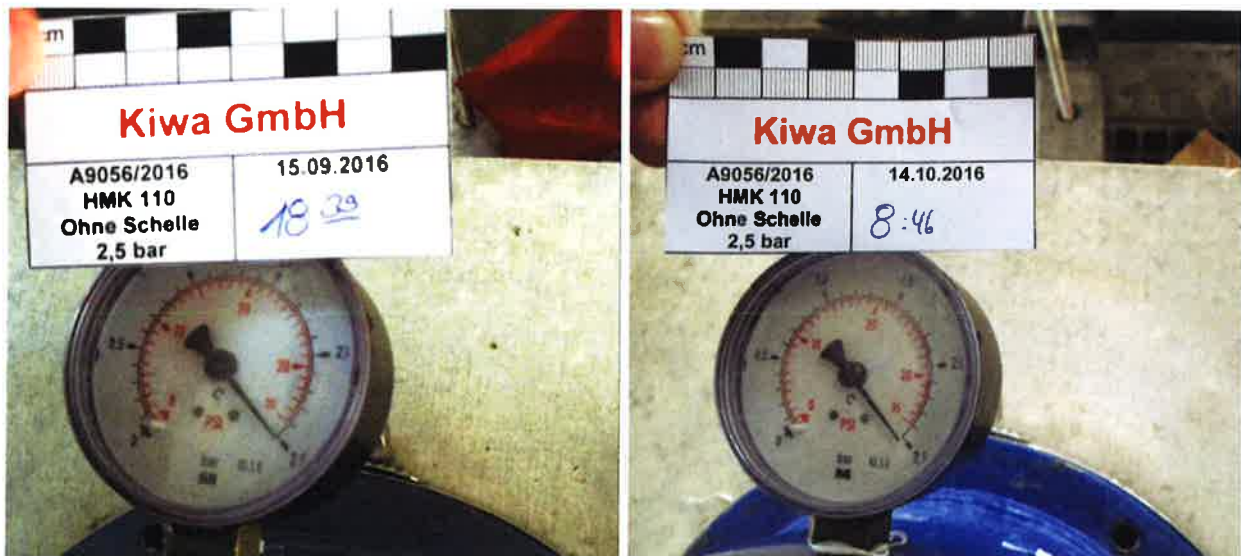
Figure A4. Water tightness test with the 2,5 bar water filled pressure bell (left: manometer on September 15<sup>th</sup>, 2016 at 6:39 pm; right: manometer after 29 days on October 14<sup>th</sup>, 2016 at 8:46 am).

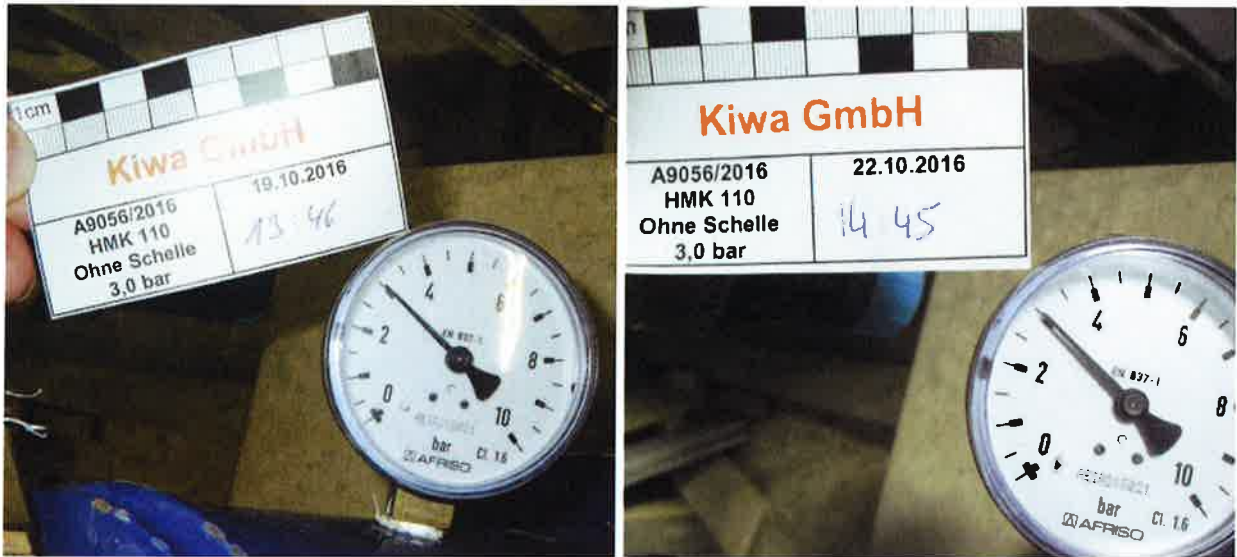
Figure A5. Water tightness test with the 3,0 bar water filled pressure bell (left: manometer on October 19<sup>th</sup>, 2016 at 1:46 pm; right: manometer after 3 days on October 22<sup>nd</sup>, 2016 at 2:45 pm).

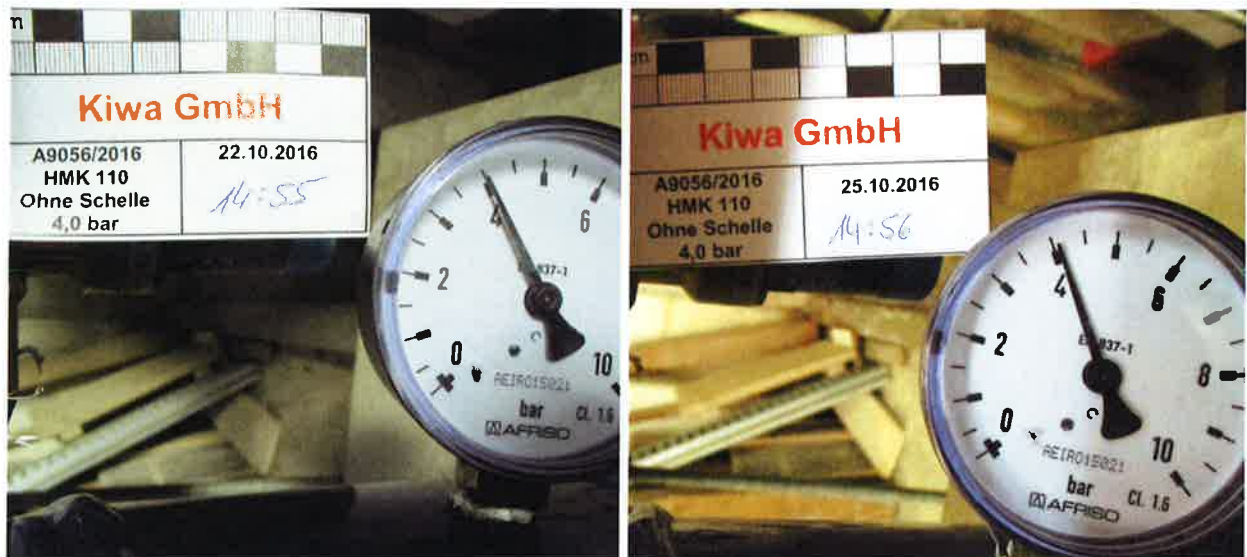
Figure A6. Water tightness test with the 4,0 bar water filled pressure bell (left: manometer on October 22<sup>nd</sup>, 2016 at 2:44 pm; right: manometer after 3 days on October 25<sup>th</sup>, 2016 at 2:56 pm).

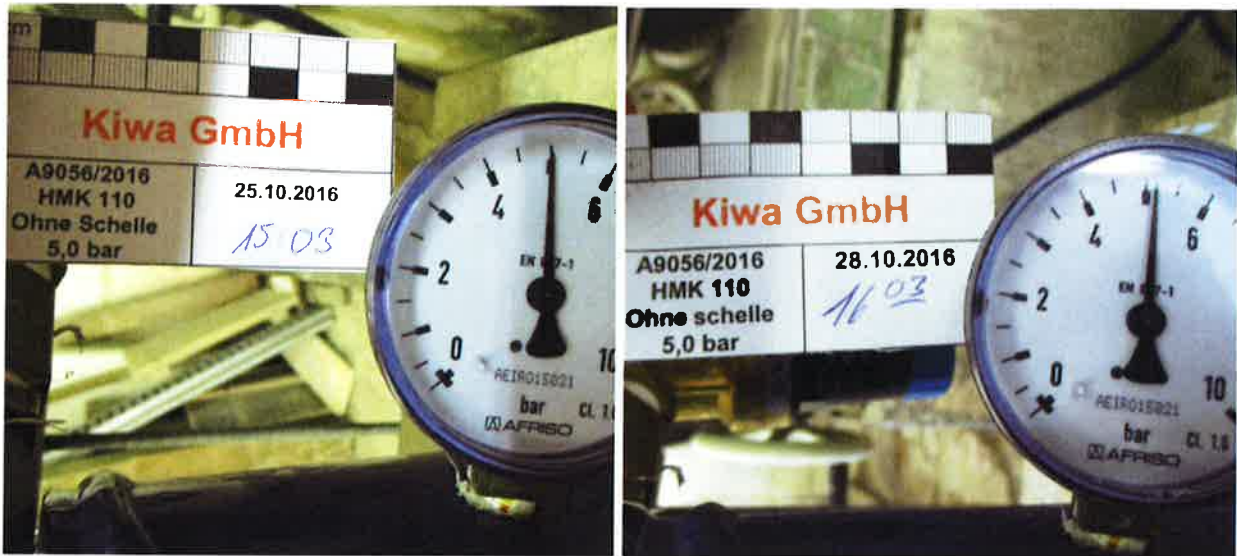
Figure A7. Water tightness test with the 5,0 bar water filled pressure bell (left: manometer on October 25<sup>nd</sup>, 2016 at 3:03 pm; right: manometer after 3 days on October 28<sup>th</sup>, 2016 at 4:03 pm).
