## Test Report

Hauff Technik GmbH & Co. KG  
Giengener Straße 35  
89428 Syrgenstein – Landshausen

Contract : Testing of the water-tightness of a wall collar  
DN110 encased in concrete with an inserted  
universal pipe DN110

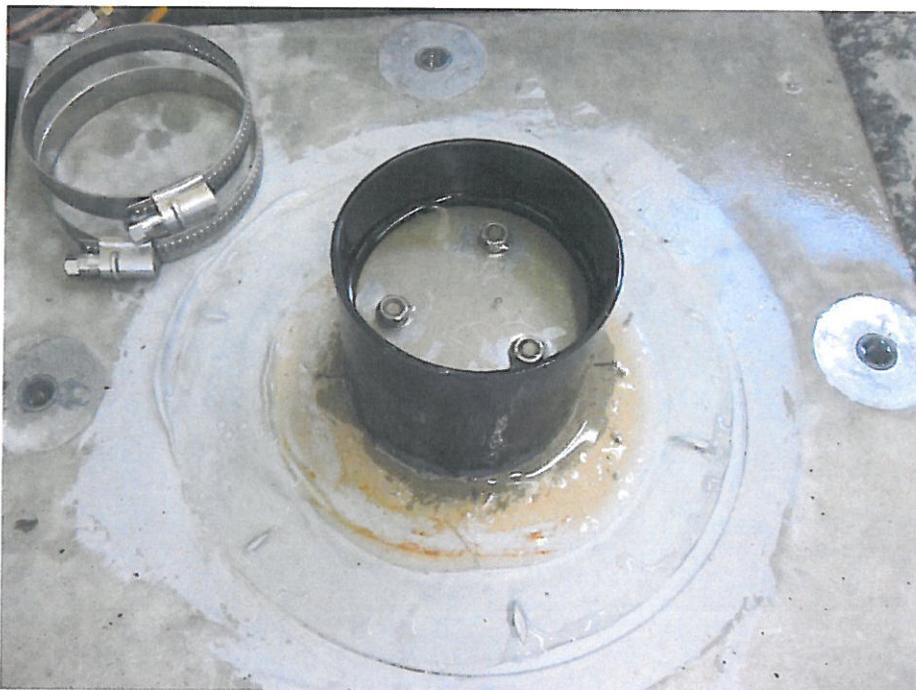
Figure 1: Pipe including internal seal

Therefore a prefabricated test setup was delivered by Hauff-Technik GmbH & Co. KG to our test laboratory in Augsburg. The test setup consists of a concrete test member with an encased wall collar DN110 with an inserted universal plastic pipe DN110 (see Figure 1 to Figure 4).

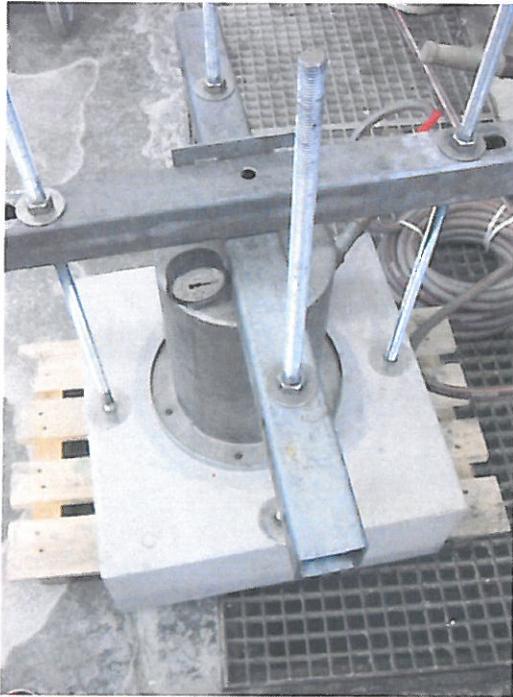
Figure 2: Test setup

Furthermore a compression bell with manometer and rubber ring seal was provided by the Manufacturer. The compression bell was designated to be put on the test member and pressed against the concrete by four tension rods (see Figure 2 and Figure 4).

The test member which was delivered by the Manufacturer was a pre-assembled concrete test member with a test setup in accordance with section 2.1 and with a pre-assembled manometer (see Figure 2 to Figure 4). A calibration of the manometer was not carried out by Kiwa MPA Bautest GmbH.

After consultation with the Manufacturer a tightness test with a water filled pressure bell over a period of 20 hours with a nominal pressure of 5,0 bar was carried out.

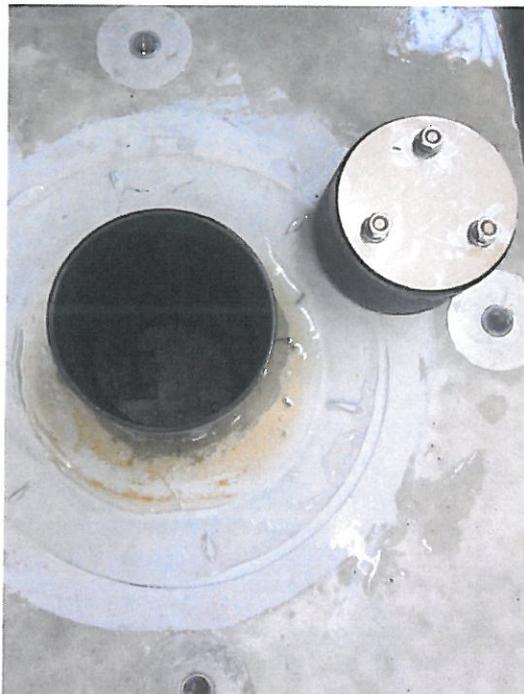
Figure 3: Pipe and internal sealing

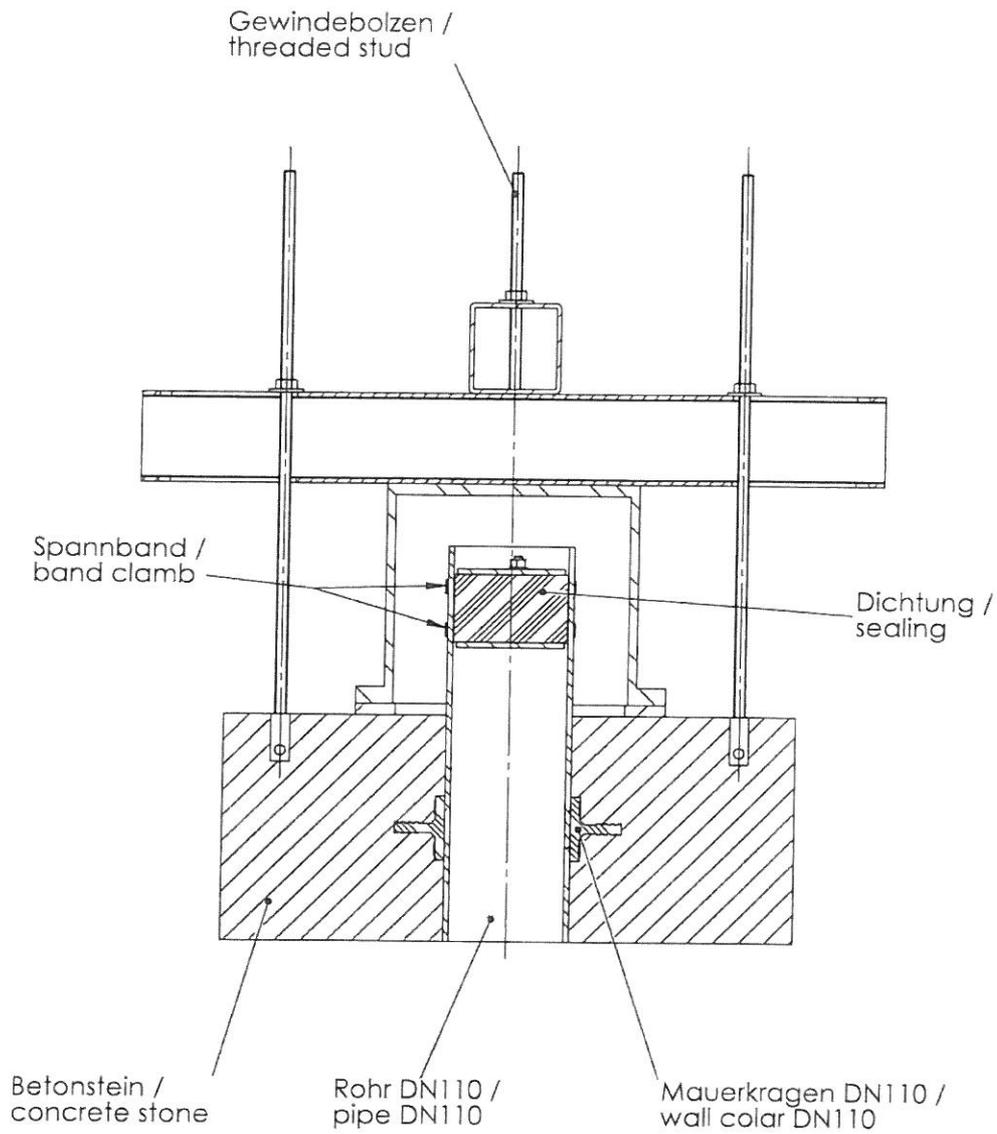
Figure 4: Test setup (drawing by the manufacturer)

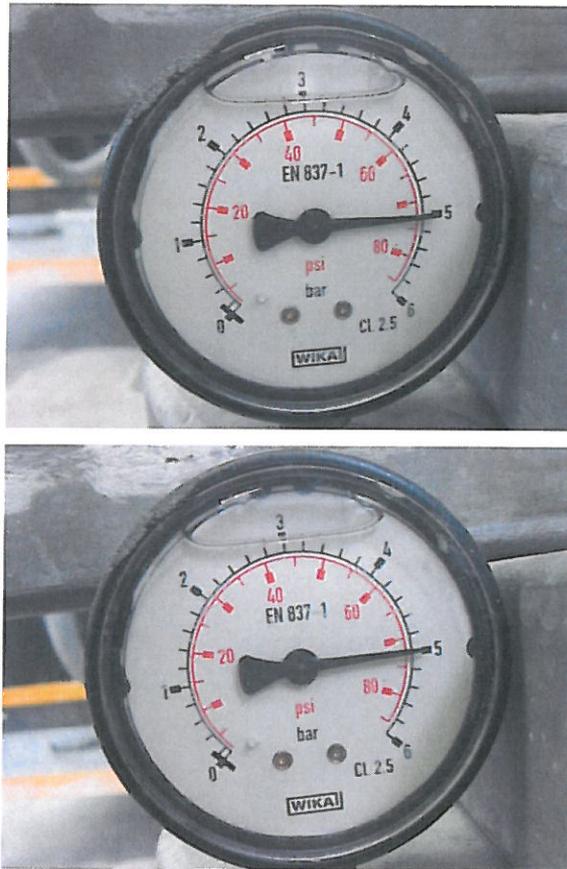
Subsequent the manometer display at the beginning and at the end of the tightness test is shown in Figure 5.

Figure 5: Tightness test with water filled pressure bell (above: manometer display at the beginning of the test at 05/30/2012 10:00; below: manometer display at the end of the test at 05/31/2012 06:00)

*During the tightness test of the wall collar DN110 with the inserted universal pipe DN110 encased in concrete with water filled pressure bell with a nominal pressure of 5.0 bar no defect in water tightness as a result of water discharge could be detected.*
