## Test Report

A 9040-1 / 2012

Contract : Testing of the gas tightness of the system cover  
HSI 150-DG-3/24-54 for building entries with  
compressed air

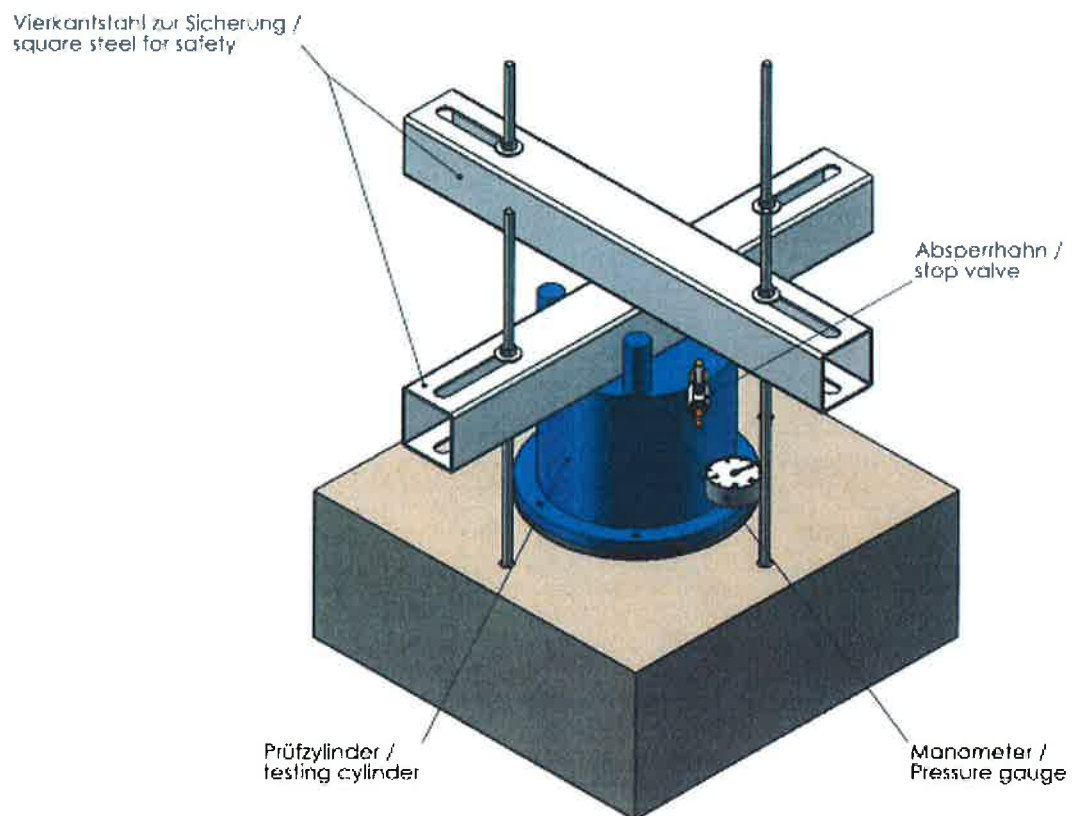
Figure 1: Test setup (drawing by the manufacturer)

The test member which was delivered by the manufacturer was a pre-assembled test member with a test setup in accordance with section 2.1 and with a pre-assembled manometer (see Figure 1). A calibration of the manometer by Kiwa MPA Bautest GmbH was not carried out.

After consultation with the manufacturer a tightness test with compressed air over a period of 24 h with a nominal pressure of 2.5 bar at room temperature was carried out with a test specimen as shown in Figure 1.

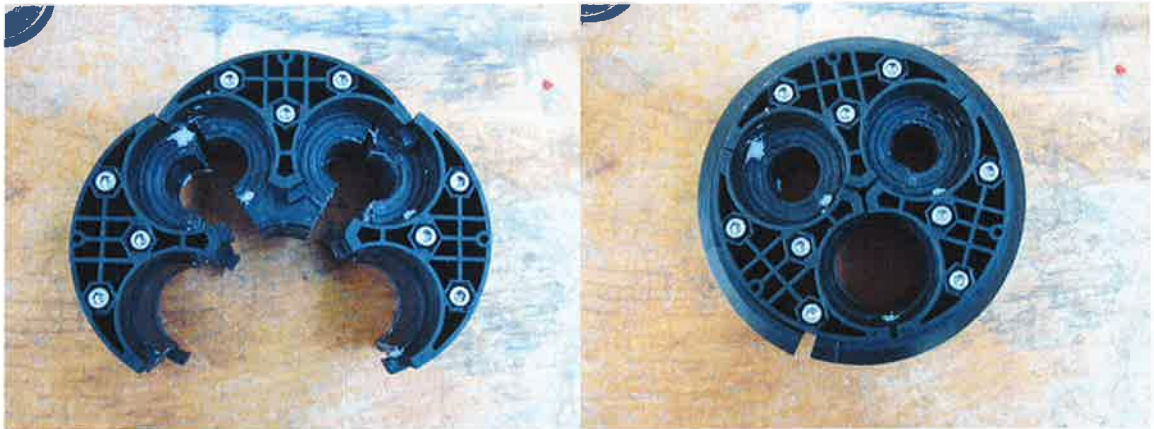
Figure 2: System cover HSI 150-DG-3/24-54

The cover system HSI 150-DG-3/24-54 was installed in a concrete test member as shown in Figure 3. The used cover system was assembled with three cable dummies as shown in Figure 2 to Figure 4.

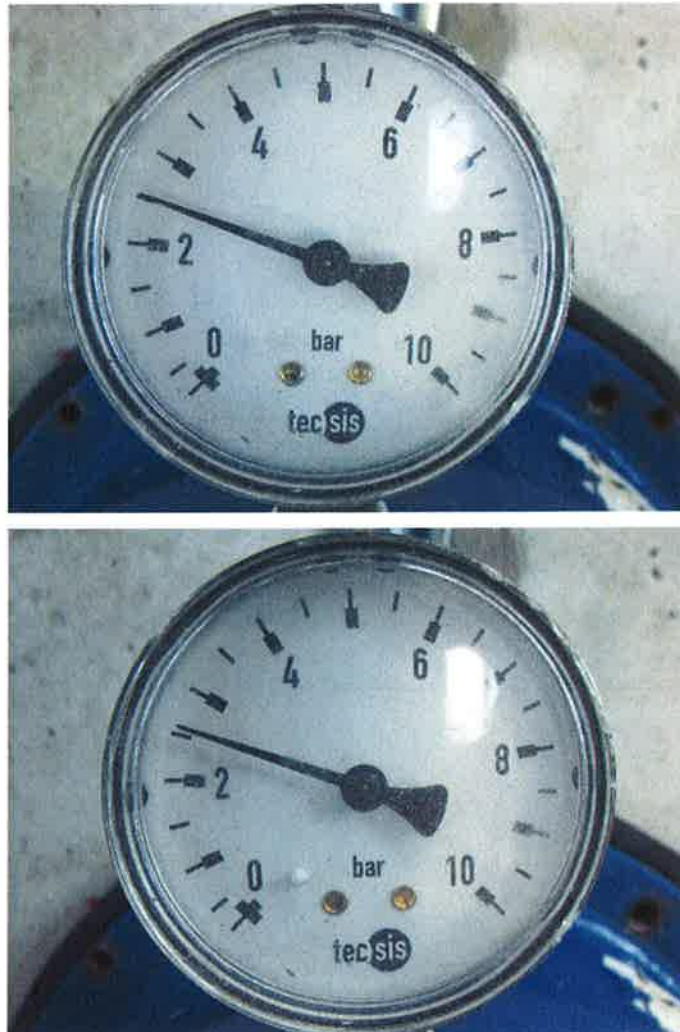
Figure 5: Tightness test with compressed air filled pressure bell at room temperature (above: manometer display at the beginning of the test at 05/30/2012 8:45; below: manometer display at the end of the test at 05/31/2012 8:45)

Subsequent in Figure 5 the manometer display at the beginning and at the end of the tightness test is shown.

*During the tightness tests of the system cover HSI 150-DG-3/24-54 at room temperature with compressed air filled pressure bell with nominal pressure of 2.5 bar over the respective test periods of 24 h no defect could be detected.*
