Test Report

A 9040-2 / 2012

Contract : Testing of the gas tightness of the system cover
HSI 150-DG-6/10-36 for building entries with
compressed air

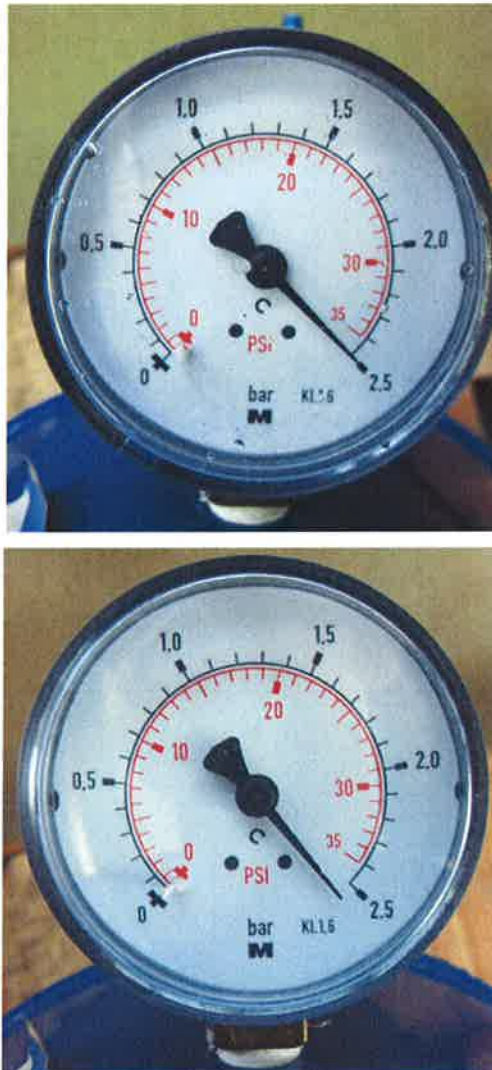
Figure 5: Tightness test with compressed air filled pressure bell at room temperature (above: manometer display at the beginning of the test at 05/30/2012 8:45; below: manometer display at the end of the test at 05/31/2012 8:45)

Subsequent in Figure 5 the manometer display at the beginning and at the end of the tightness test are shown.

During the tightness tests of the system cover HSI 150-DG-6/10-36 at room temperature with compressed air filled pressure bell with nominal pressure of 2.5 bar over the respective test periods of 24 h no defect could be detected.
