Test Report

A 9072-4 / 2009

Contract : Testing of the water-tightness of a cable lead-through

System HSI 150-K2 packing and installed system cover HSI 150-S3 Segmento

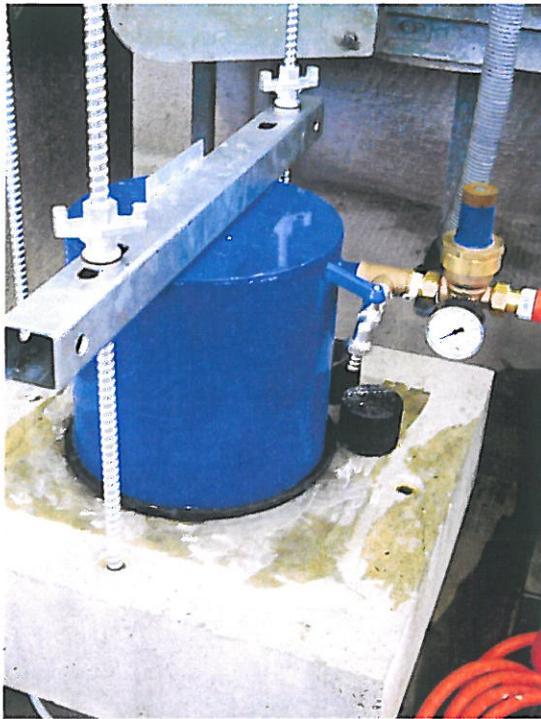
Figure 2: Test setup

The test member which was delivered by the Manufacturer was a pre-assembled concrete test member with a test setup in accordance with section 2.1 and with a pre-assembled manometer and pressure regulator (see Figure 2 to Figure 4). A calibration of the manometer and the pressure regulator was not carried out by Kiwa Bautest GmbH.
