Project / Plant: Water tightness test of the stainless steel flange Hauff HRD150-F/100 for retrofit dowelling on a concrete test block with exterior waterproofing PCI Pecimor 2K (waterproofing class W2.1E according to DIN 18533-1)

Product description: Stainless steel flange Hauff HRD150-F/100 for retrofit dowelling

Order: Water tightness test $\geq 1,0$ bar for 28 days

Remark: Translation of Test Report A1742032-01,
15 June 2018

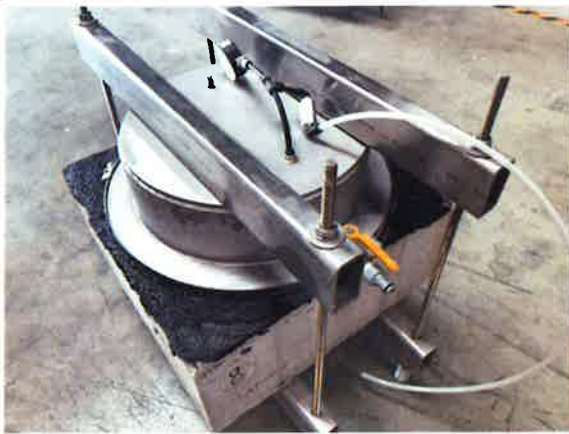
Figure 1. Assembled test setup.

Therefore Hauff-Technik GmbH & Co. KG delivered the concrete test block with the already installed stainless steel flange Hauff HRD150-F/100 together with the components for the test setup to our test laboratory in Gersthofen, Germany. The surface of the test block which was charged with water pressure was already finished with the exterior waterproofing polymer modified bituminous coating (PMBC) PCI Pecimor 2K [4] according to DIN EN 15814 [5]. The assembly of the test setup was performed by an employee of Hauff-Technik GmbH & Co. KG (see Figure 1).

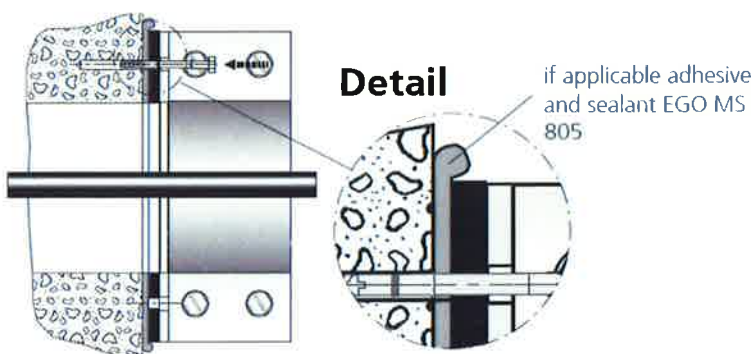
Figure 2. Example of installation of the stainless steel flange Hauff HRD150-F/100 (picture of the manufacturer).

Then the flange was pressed onto the wall and the pre-installed screws with sealing disc and insert fastening dowels were hit in until the dowels were flush with the shaft (see Figure 2).

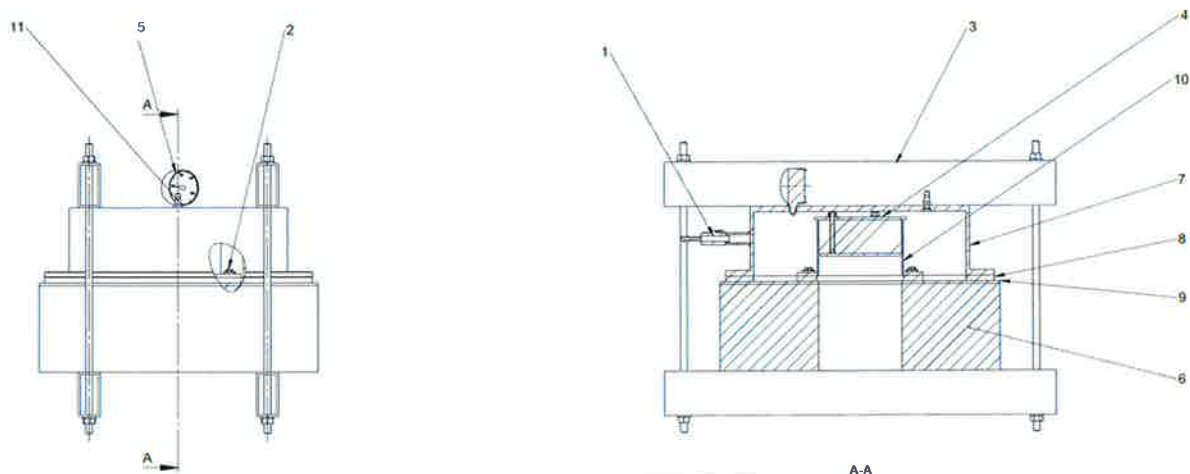
Figure 3. Detail of the test setup - manufacturer's drawing.

The test setup which was assembled by Hauff-Technik GmbH & Co. KG was built up in accordance to Section 3.1 with one manometer (see Figure 3).
