Test Report

Product : Plastic flange Hauff HSI150-DFK for retrofit
dowelling

Project : Testing of the water tightness of the plastic
flange Hauff HSI150-DFK for retrofit dowelling
onto a concrete specimen with polymer-
enhanced bituminous thick-coat system

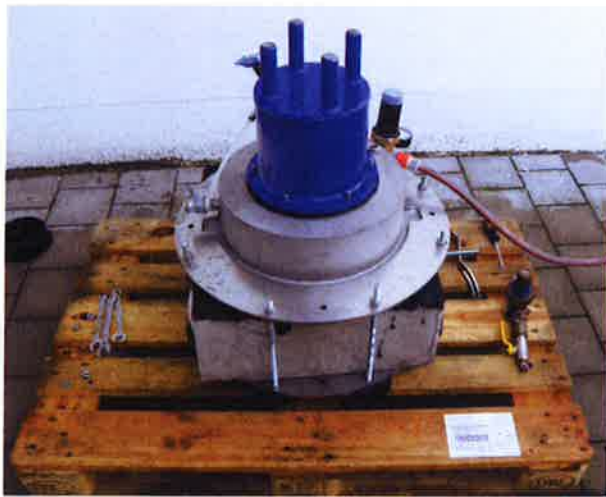
Figure 1. Delivered test setup.

Therefore an assembled test setup with a dowelled plastic flange Hauff HSI150-DFK was delivered by Hauff-Technik GmbH & Co. KG to our test laboratory in Augsburg, Germany (see Figure 1).

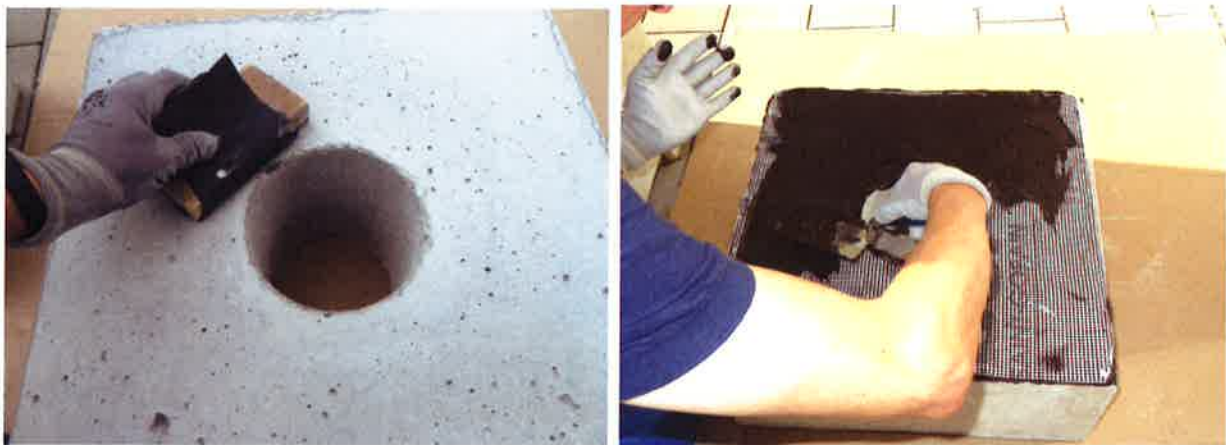
Figure 2. Leveling of the uncast concrete surface (left) and applying of the polymer-enhanced bituminous thick-coat system (right).

The uncast surface of the concrete specimen was leveled (see Figure 2 - left) and cleaned before a polymer-enhanced bituminous thick-coat system consisting of two layers and a layer of reinforcement fabric between was applied (see Figure 2 - right).

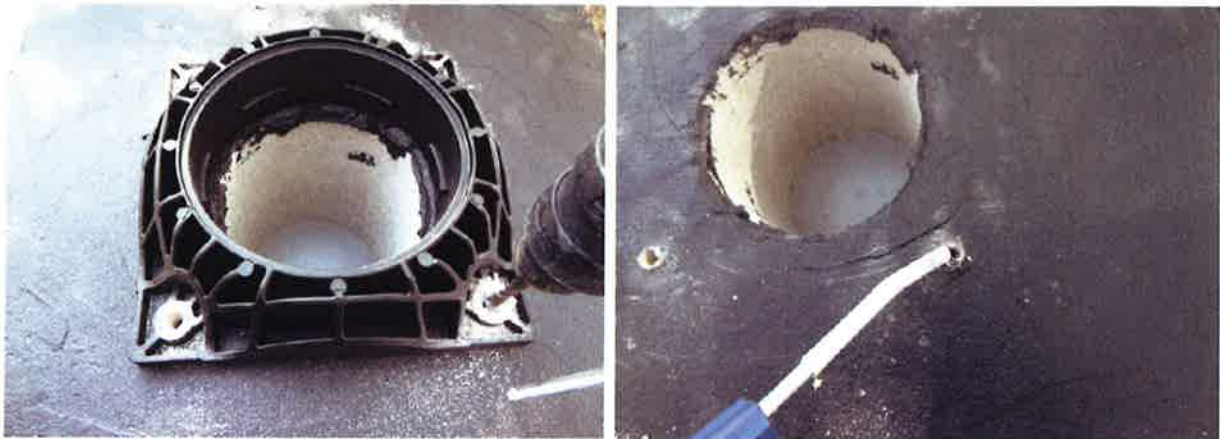
Figure 3. Drilling (left) und cleaning (right) of the dowel holes.

After curing of the polymer-enhanced bituminous thick-coat system the plastic flange was placed over the core drill and aligned horizontally for drilling (see Figure 3 - left) the dowel holes (\varnothing 10 mm, 80 mm deep). The dowel holes were cleaned according to Figure 3 - right.

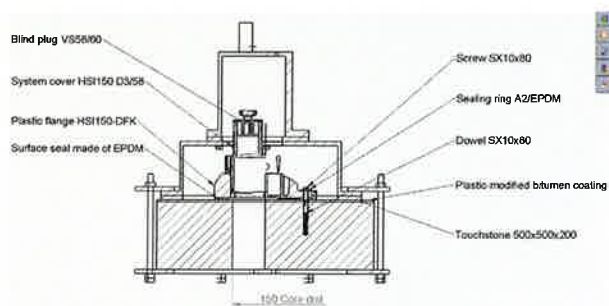
Figure 4. Detail of the test setup - manufacturer`s drawing.

The test setup which was assembled by Hauff-Technik GmbH & Co. KG was built up in accordance to Section 2.1 with one manometer (see Figure 4 to Figure 6).

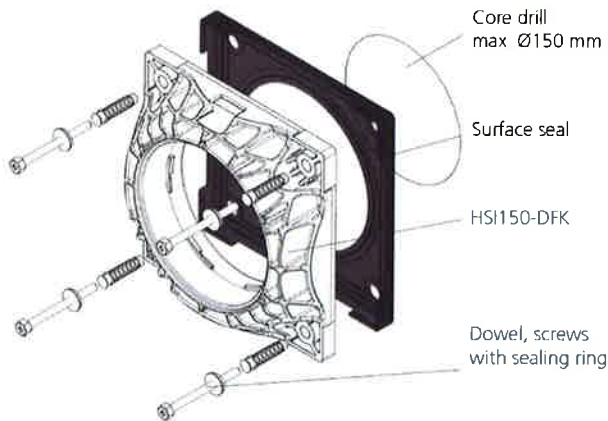
Figure 5. Detail of the plastic flange Hauff HSI150-DFK.

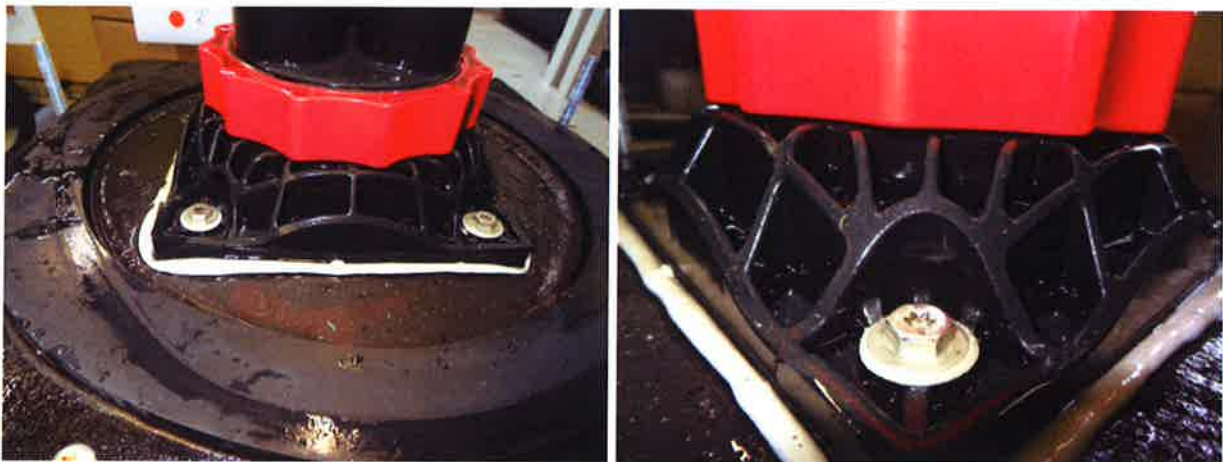
Figure 6. Plastic flange Hauff HSI150-DFK after removing the pressure bell.

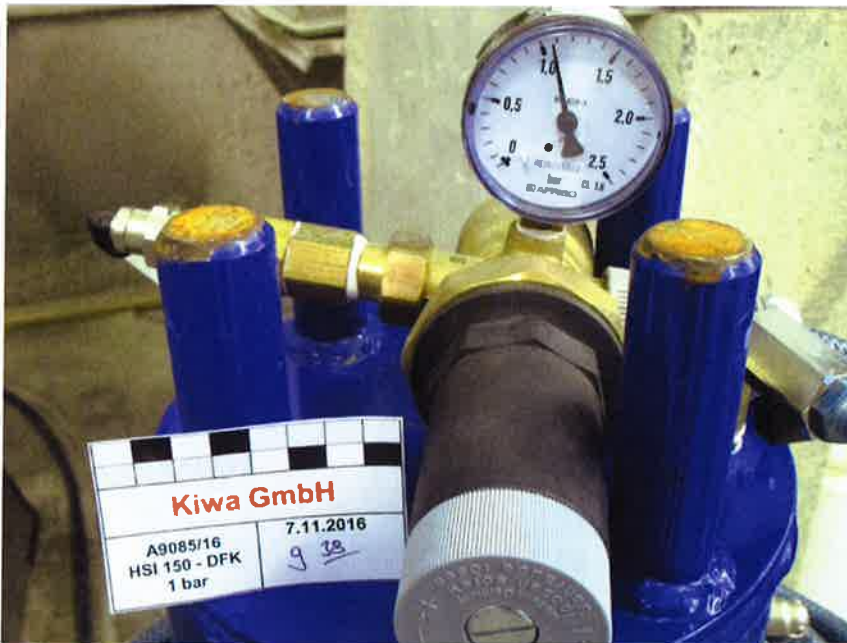
Figure A1. Water tightness test with the $\geq 1,0$ bar water filled pressure bell (manometer at the beginning of testing on November 7th, 2016 at 9:38 am).

During the water tightness test no leakages were detected (see Table 1). The water pressure depending on the testing period can be seen at Figure A1 to Figure A2 attached in the annex.

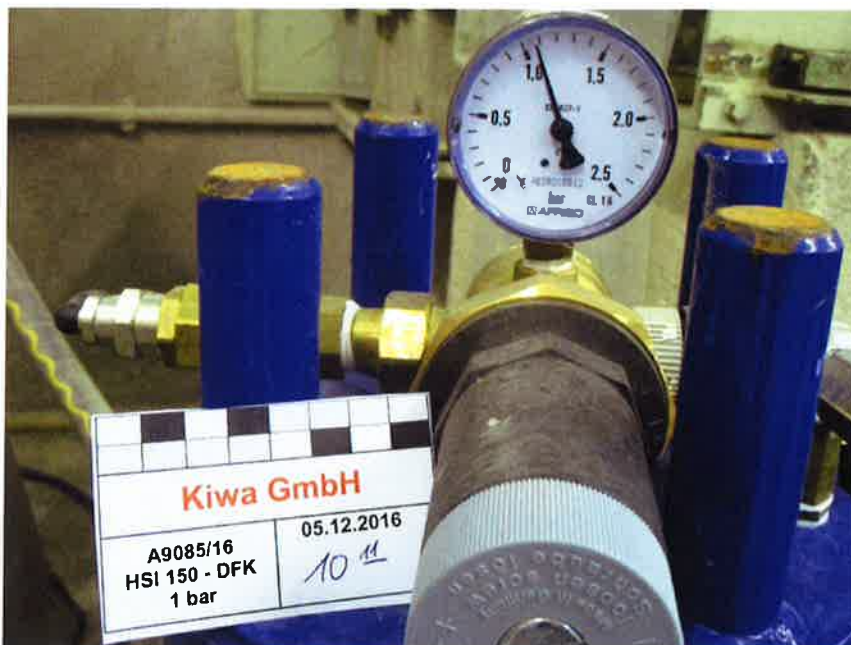
Figure A2. Water tightness test with the $\geq 1,0$ bar water filled pressure bell (manometer after 28 days on December 5th, 2016 at 10:11 am).
